# RECOMMENDATIONS FOR DESIGN OF A COASTAL PROTECTION SYSTEM FOR SHORELINE PROTECTION YAREN DISTRICT, REPUBLIC OF NAURU (RON)

May 2001

SOPAC Technical Report 317

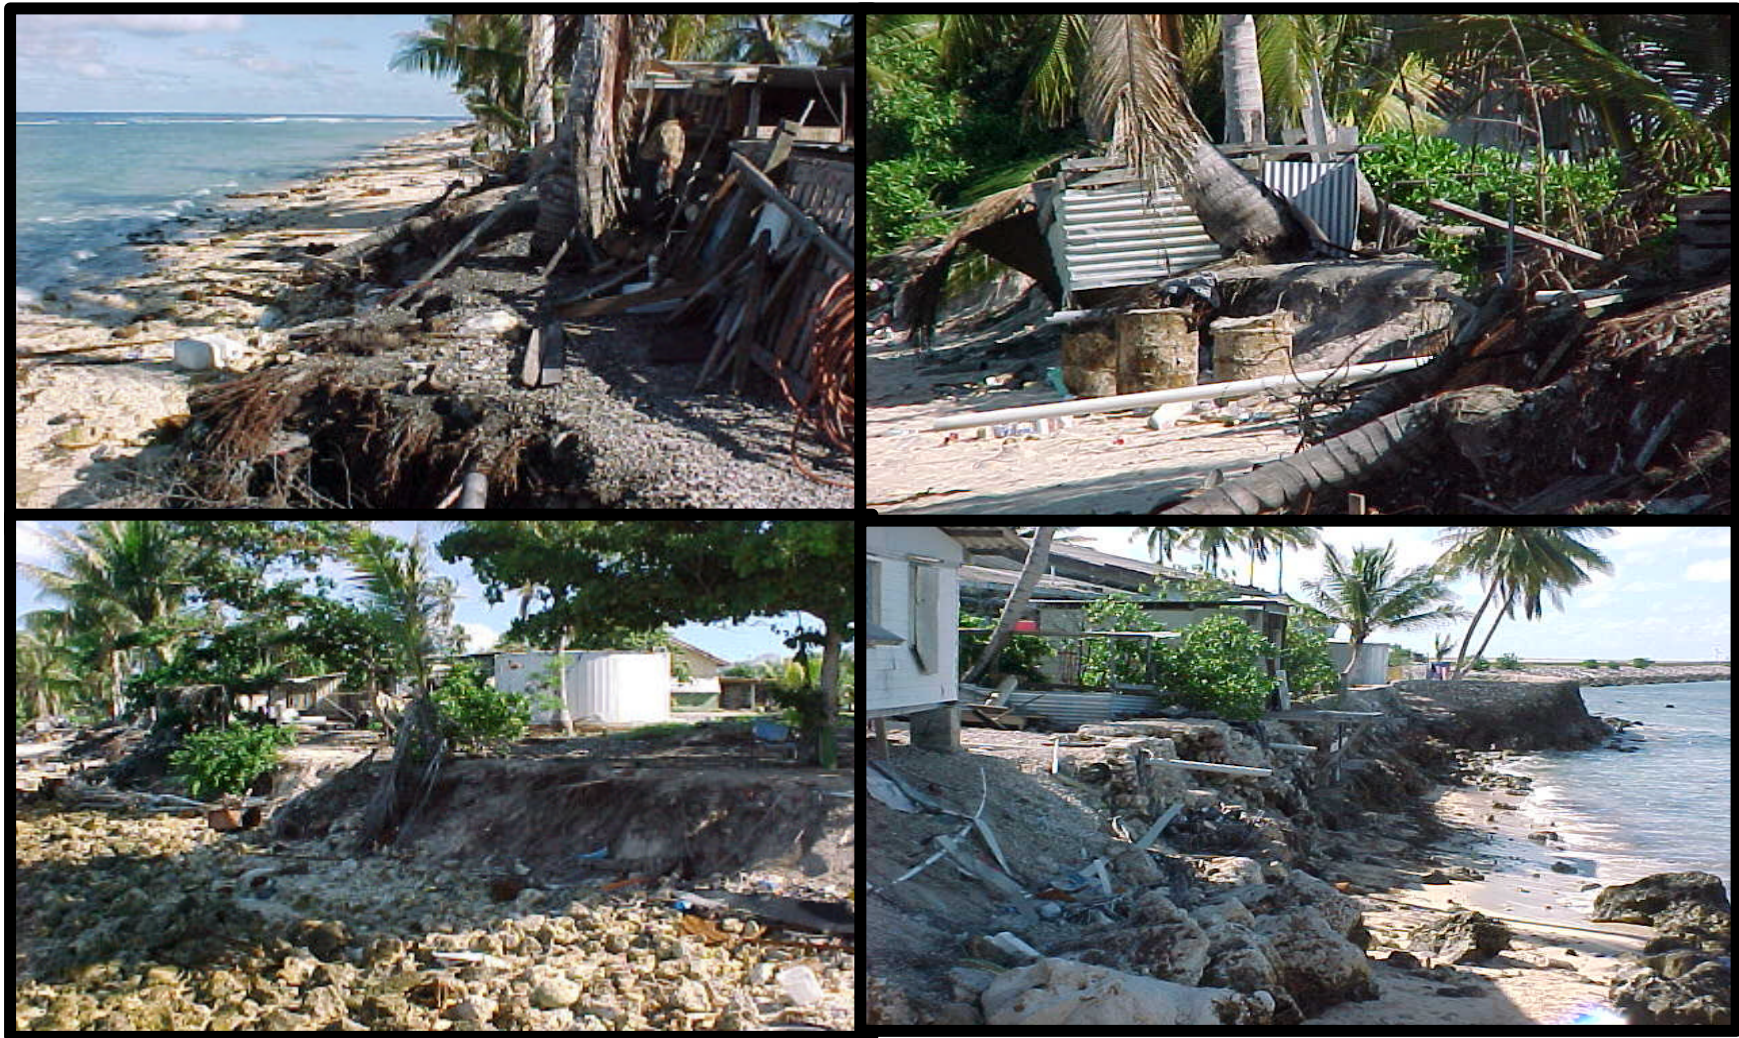
- shorefront vegetation is largely small shrubs currently being affected by erosion (Figure 4);
- residential properties front the upper beach and the shoreline (Figure 6);

- the erosion scarp at the problem coastline is between 0.80 m and 1.75 m high (Figures 4 and 5);
- the erosion scarp is vertical, with some overhanging sections where coconut palm roots still bind shallow and surface soils (Figure 4);

- in addition, older coastal protection is evident here at the study sites, from the litter of limestone boulders and masonry wall rubble, along the upper beach (Figure 4);

Figure 4. Erosion characteristics of the problematic coastline.

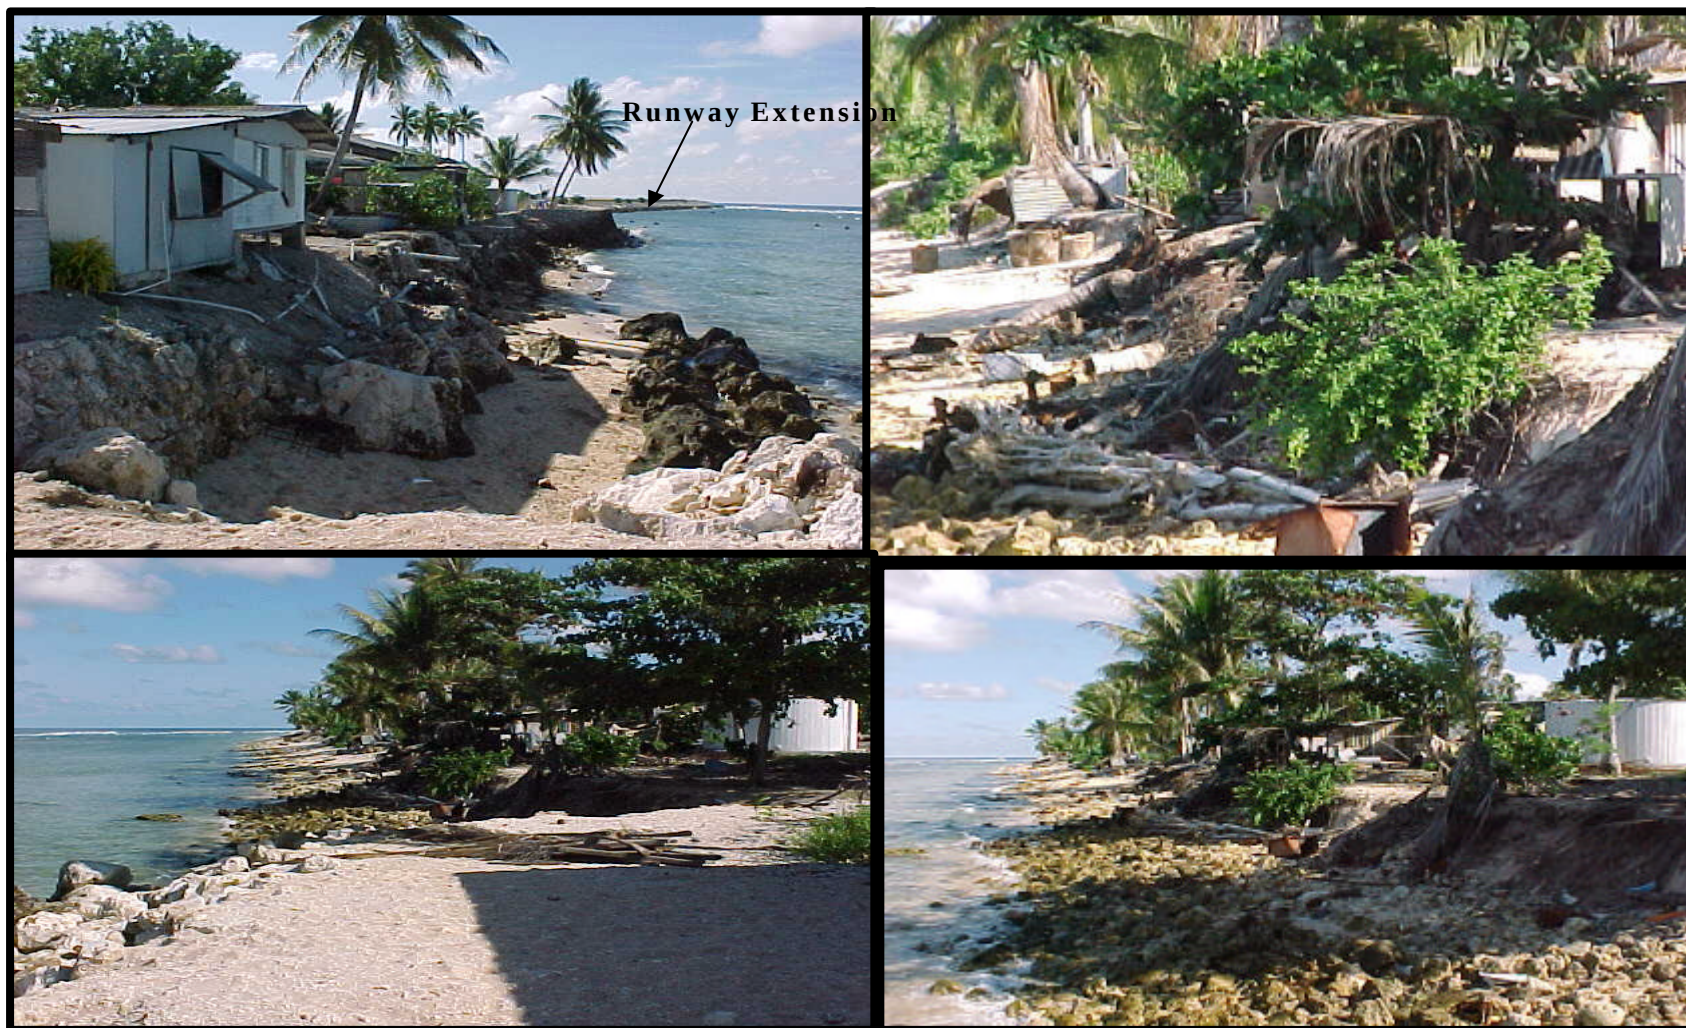
Figure 5. Erosion characteristics of the problematic coastline.

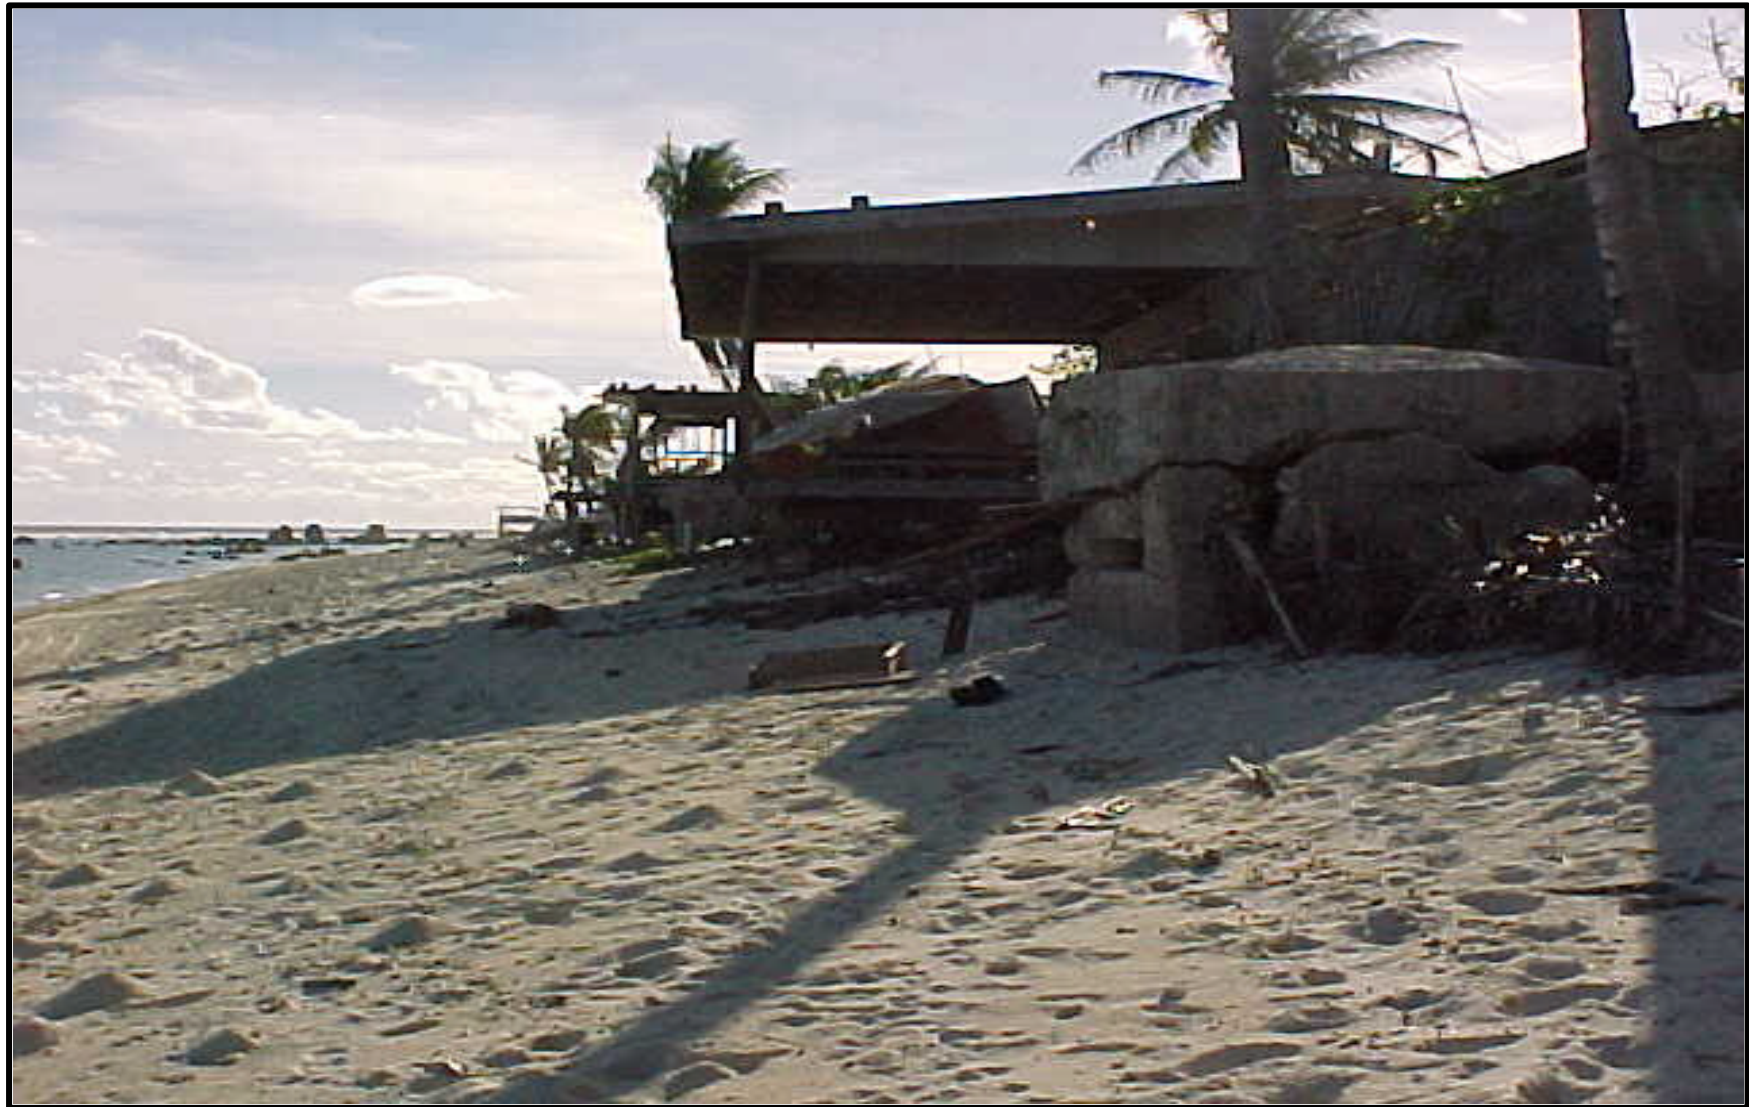
- a medium to fine, carbonate sand beach,
- the beach is about 6 m wide with a 12-15° slope towards the sea (Figure 6);
- sands are clean, with less than 5 % fines;

Figure 6. Characteristics of the eroding beach (looking west).

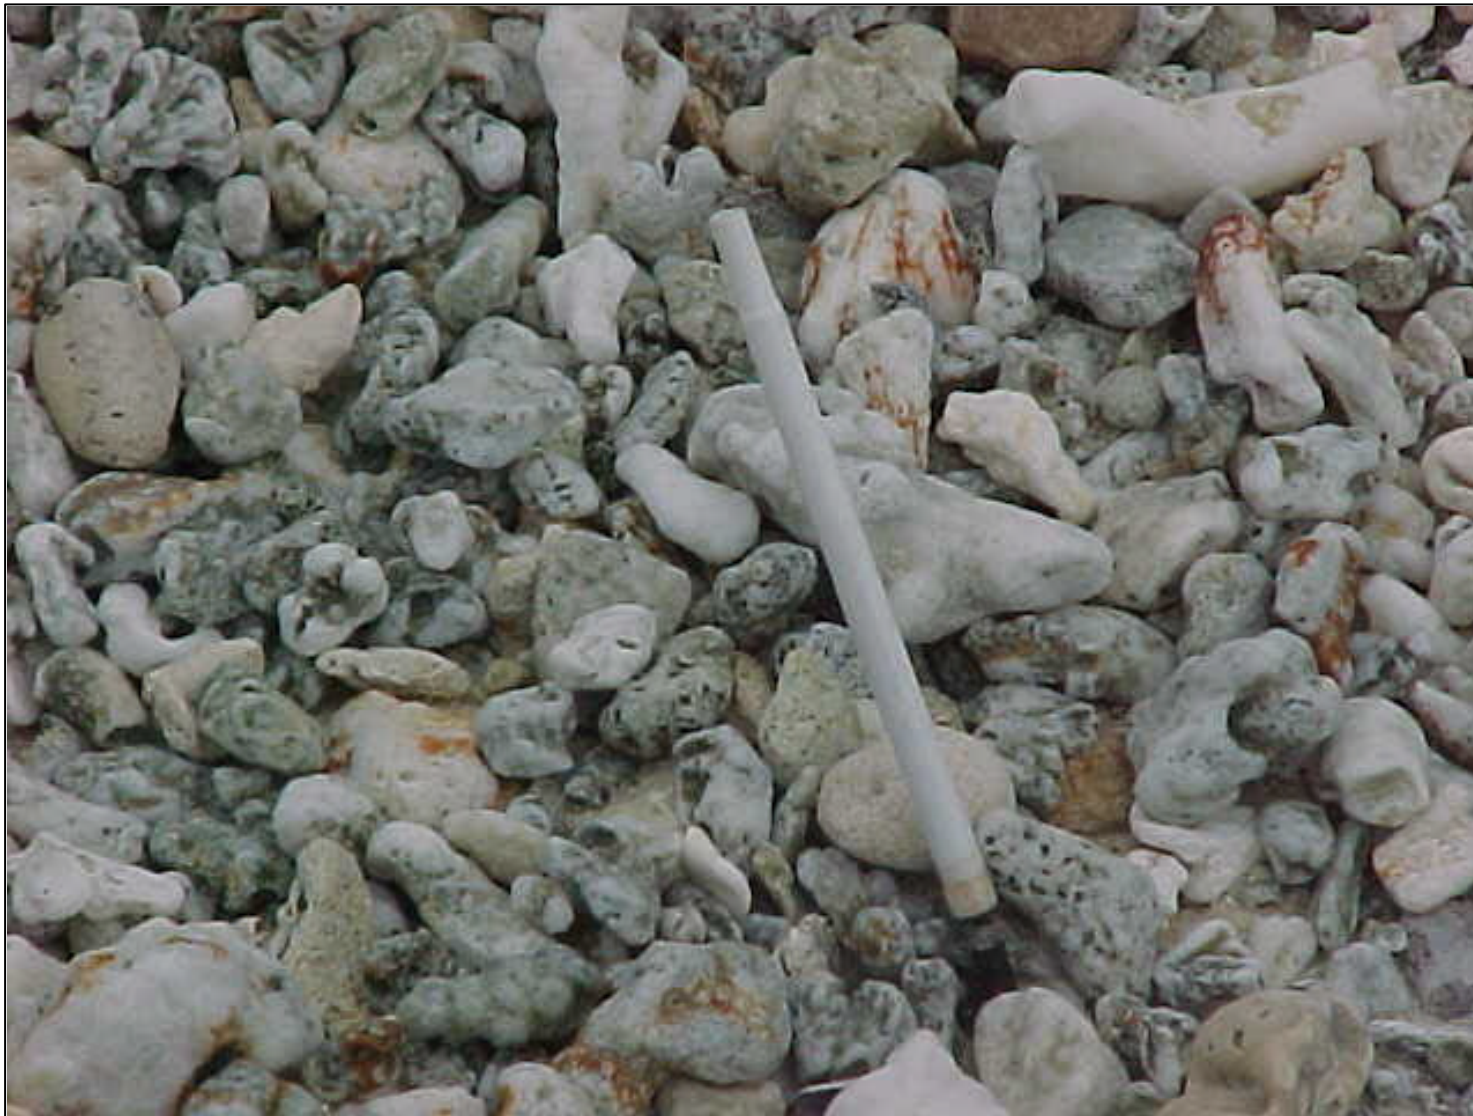
- all of these boulders are typical cavernous, dolomite limestone;
- the interface of the lower beach and backreef area is a depositional site for medium to coarse gravel (Figure 8);

- all gravel fragments have a high aspect ratio (Figure 8).

Figure 8. Carbonate gravel deposited along the lower beach. Note pen for scale.

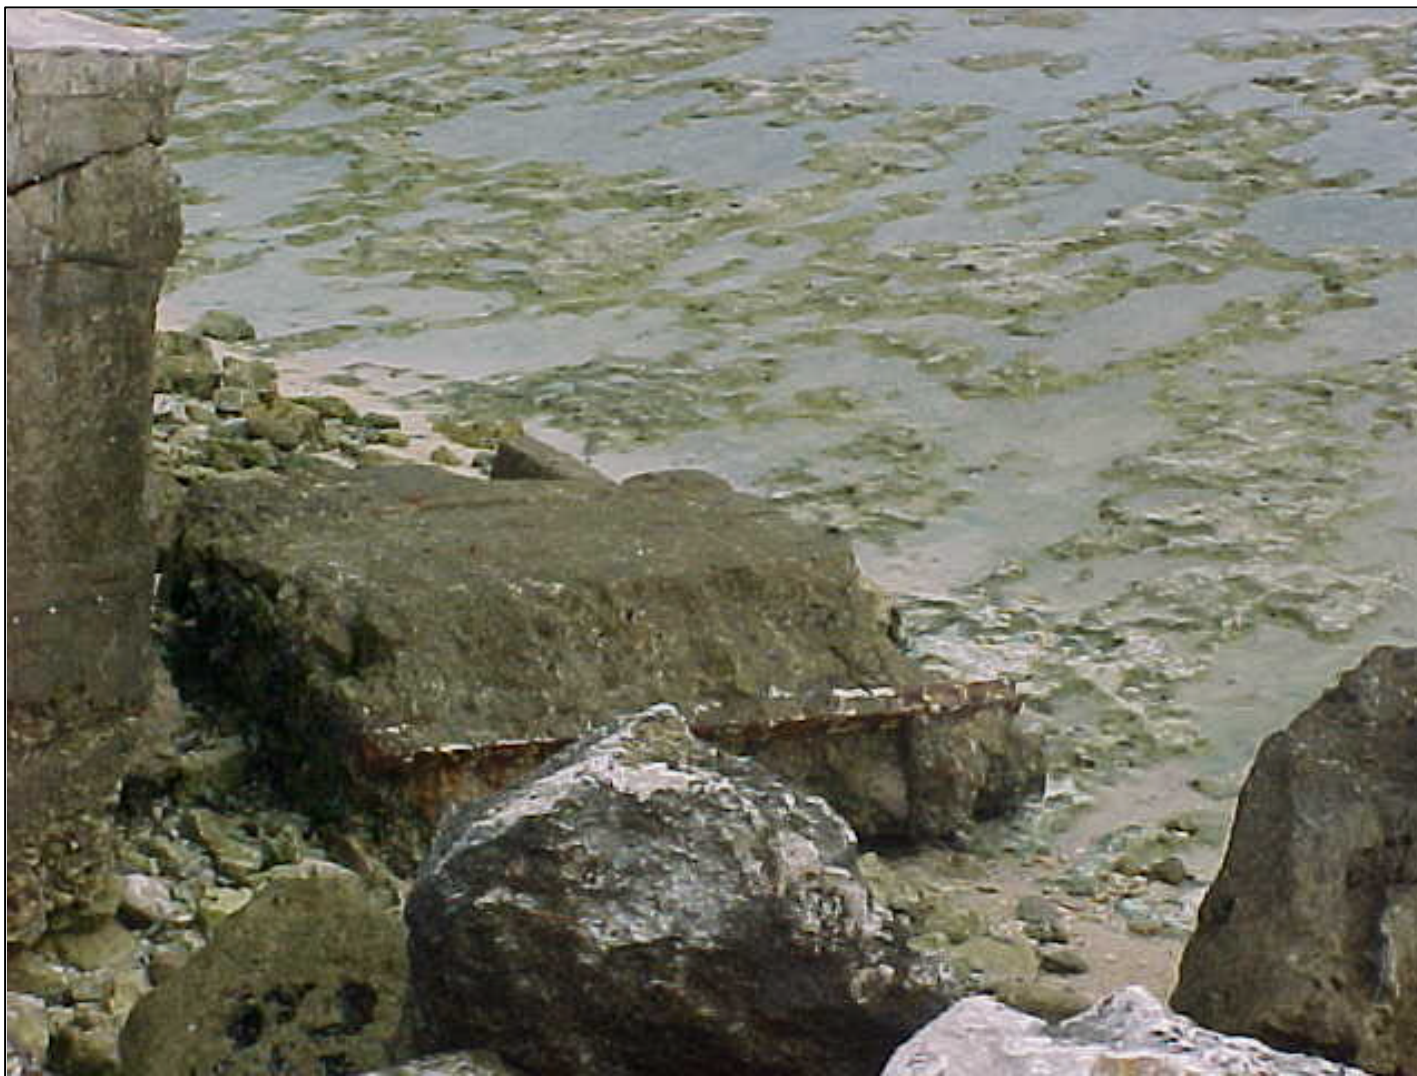
- the lower beach and backreef areas are 50 % covered with green filamentous algae (Figures 9 and 10);
- these indicate polluted and/or eutrophic (nutrient-enriched) waters; and
- macrobenthic species are common on the beach and backreef and include green algae, red algae, sea cucumbers; sea urchins and molluscs (Figure 11) attached to rock substrate.

Figure 9. Filamentous green algae covering the backreef area.

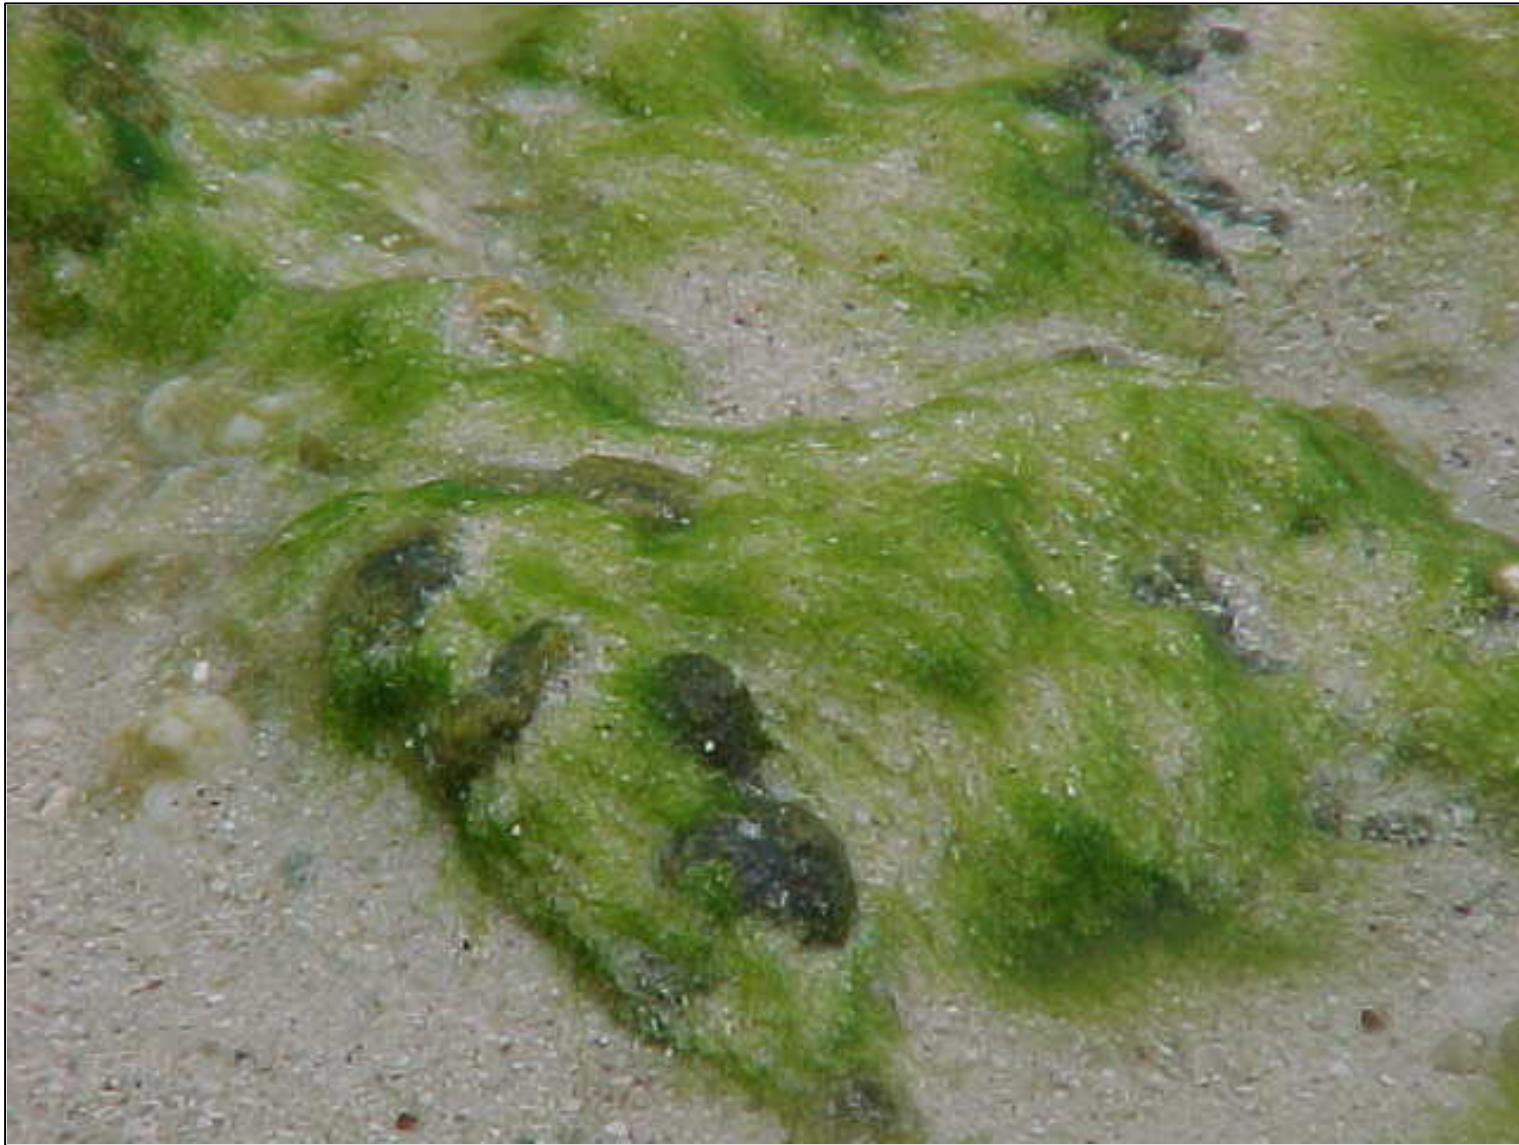
*Figure 10. Filamentous green algae on underlying limestone bedrock.*

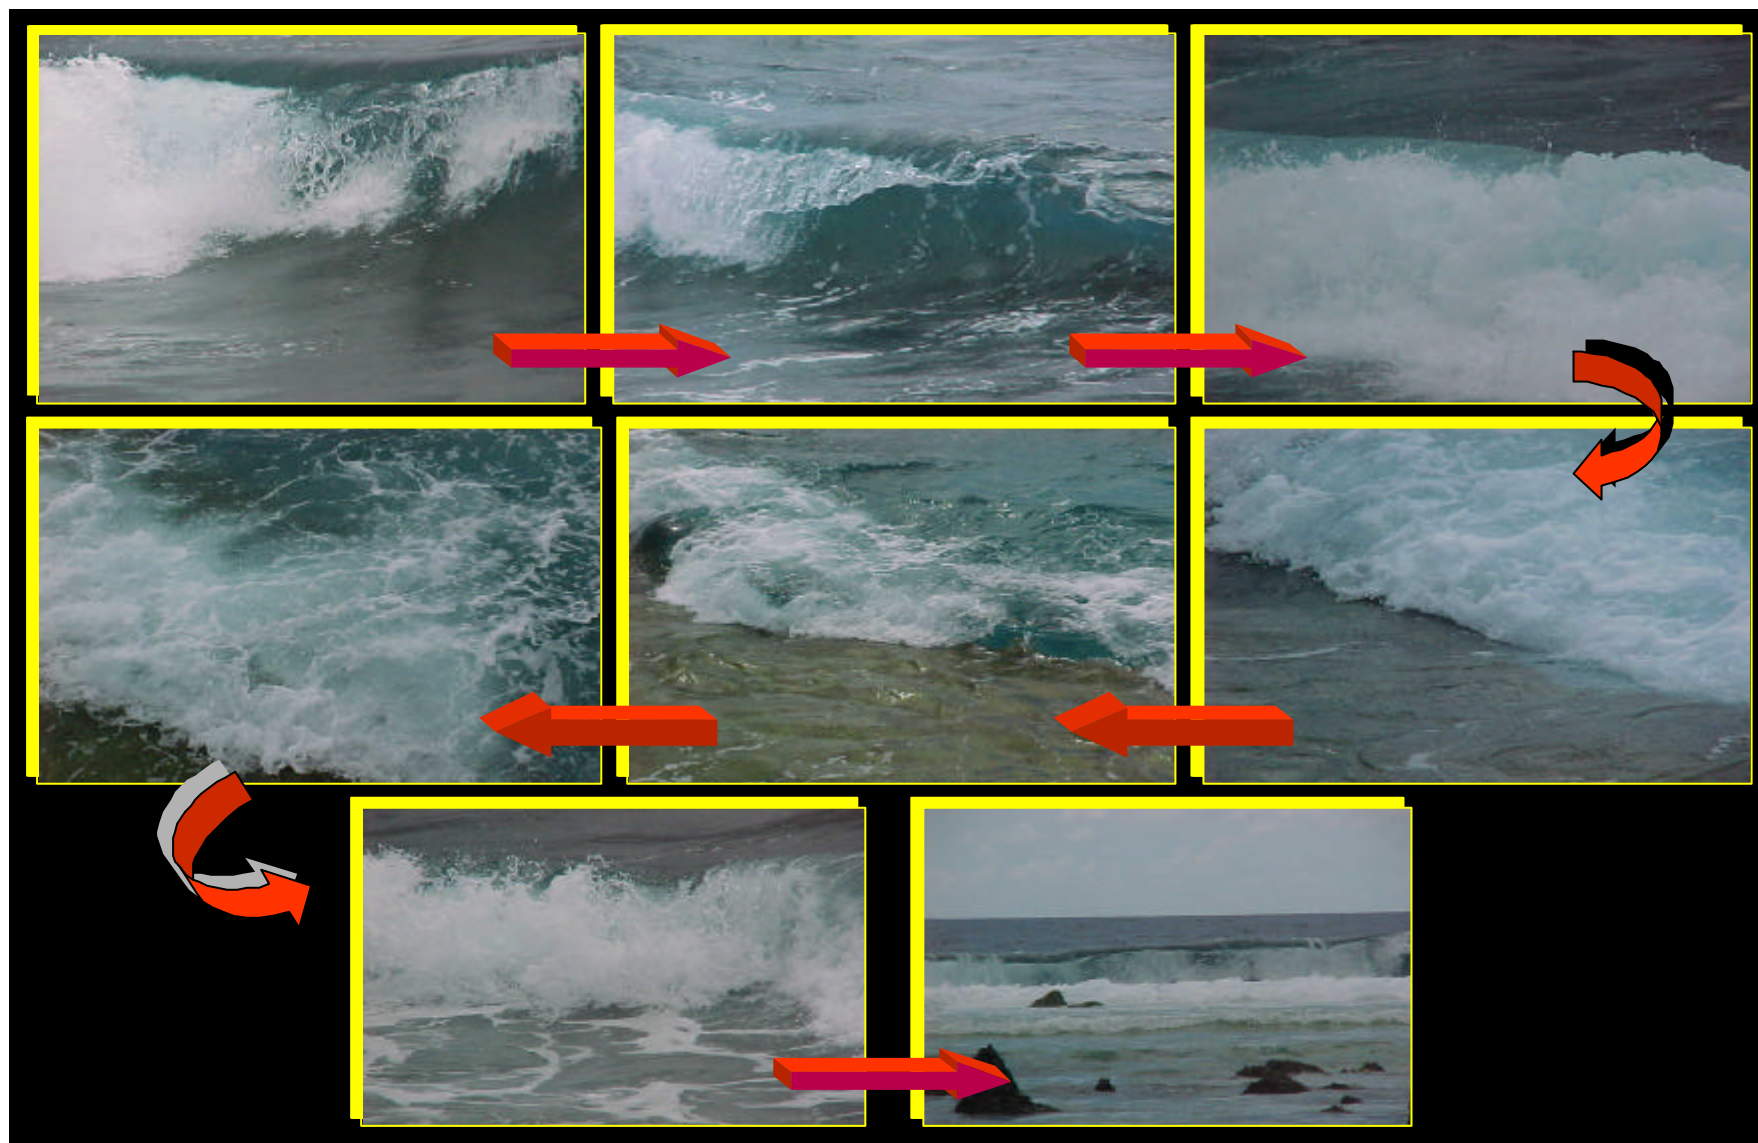
- a typical example of a plunging breaker wave sequence, and photographed at the site, is illustrated in Figure 12 (starting top left and following the arrows);

- as with typical plunging breakers, waves crash on the beach and run-up with significant speed, causing significant removal of loose/cohesionless beach sediments;

Figure 12. A plunger breaker wave sequence photographed at the site.

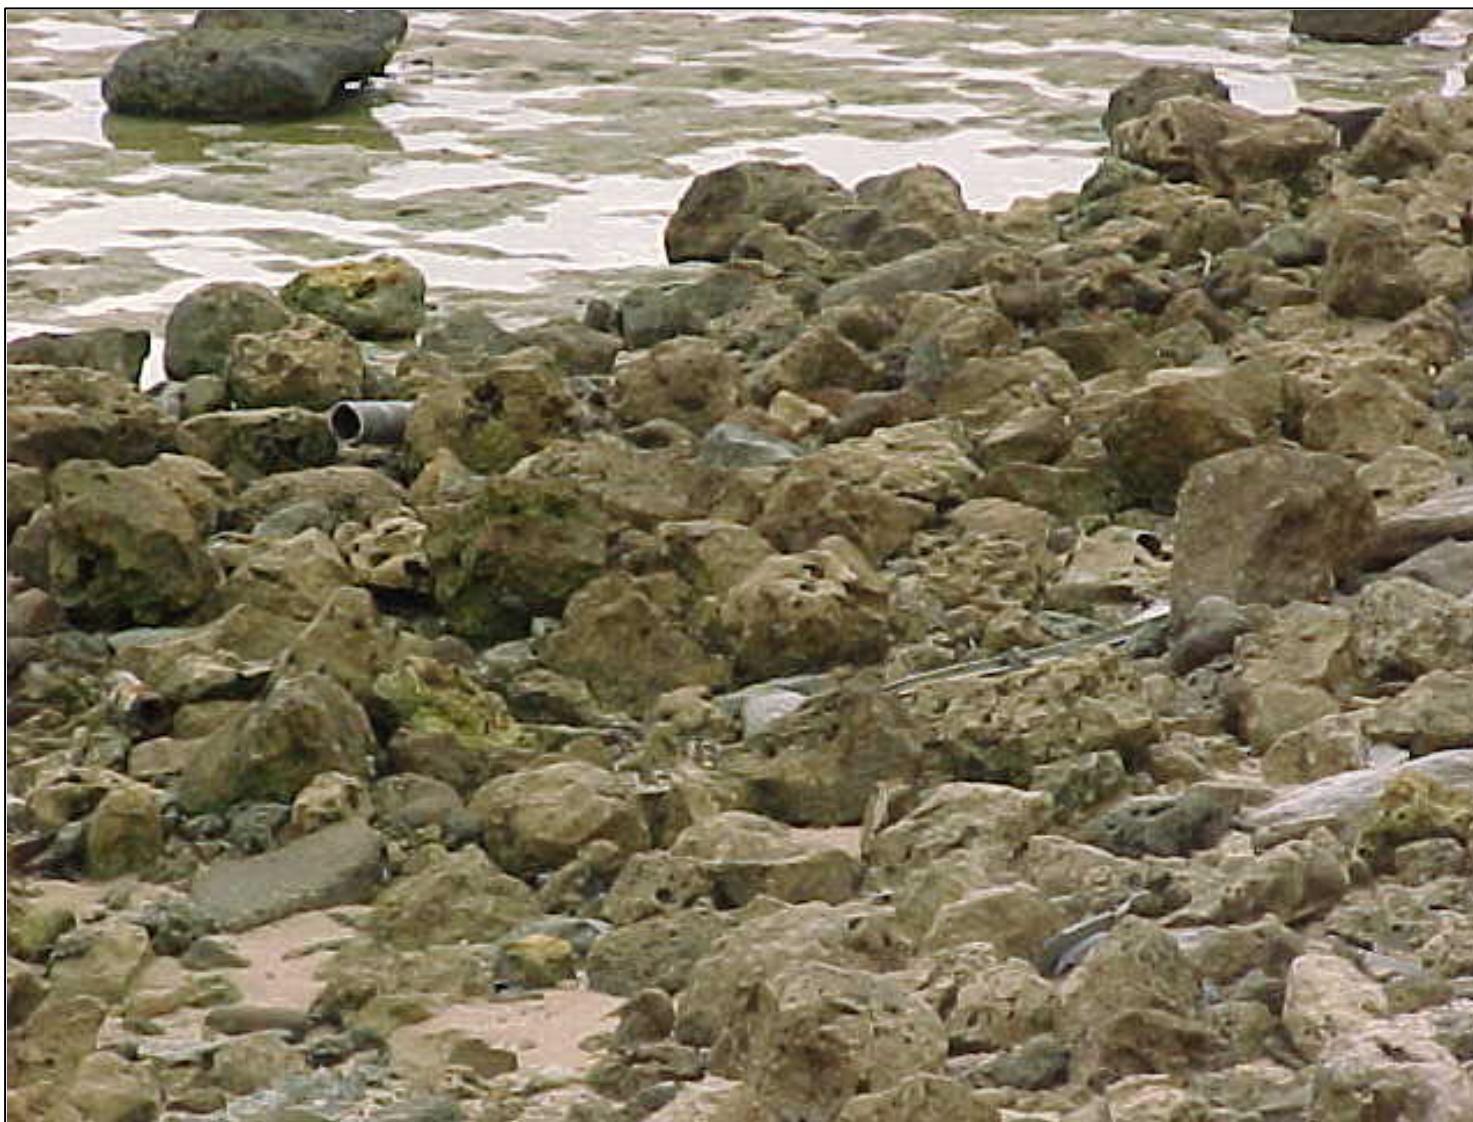
Figure 17. Limestone boulders from failed coastal protection structures.

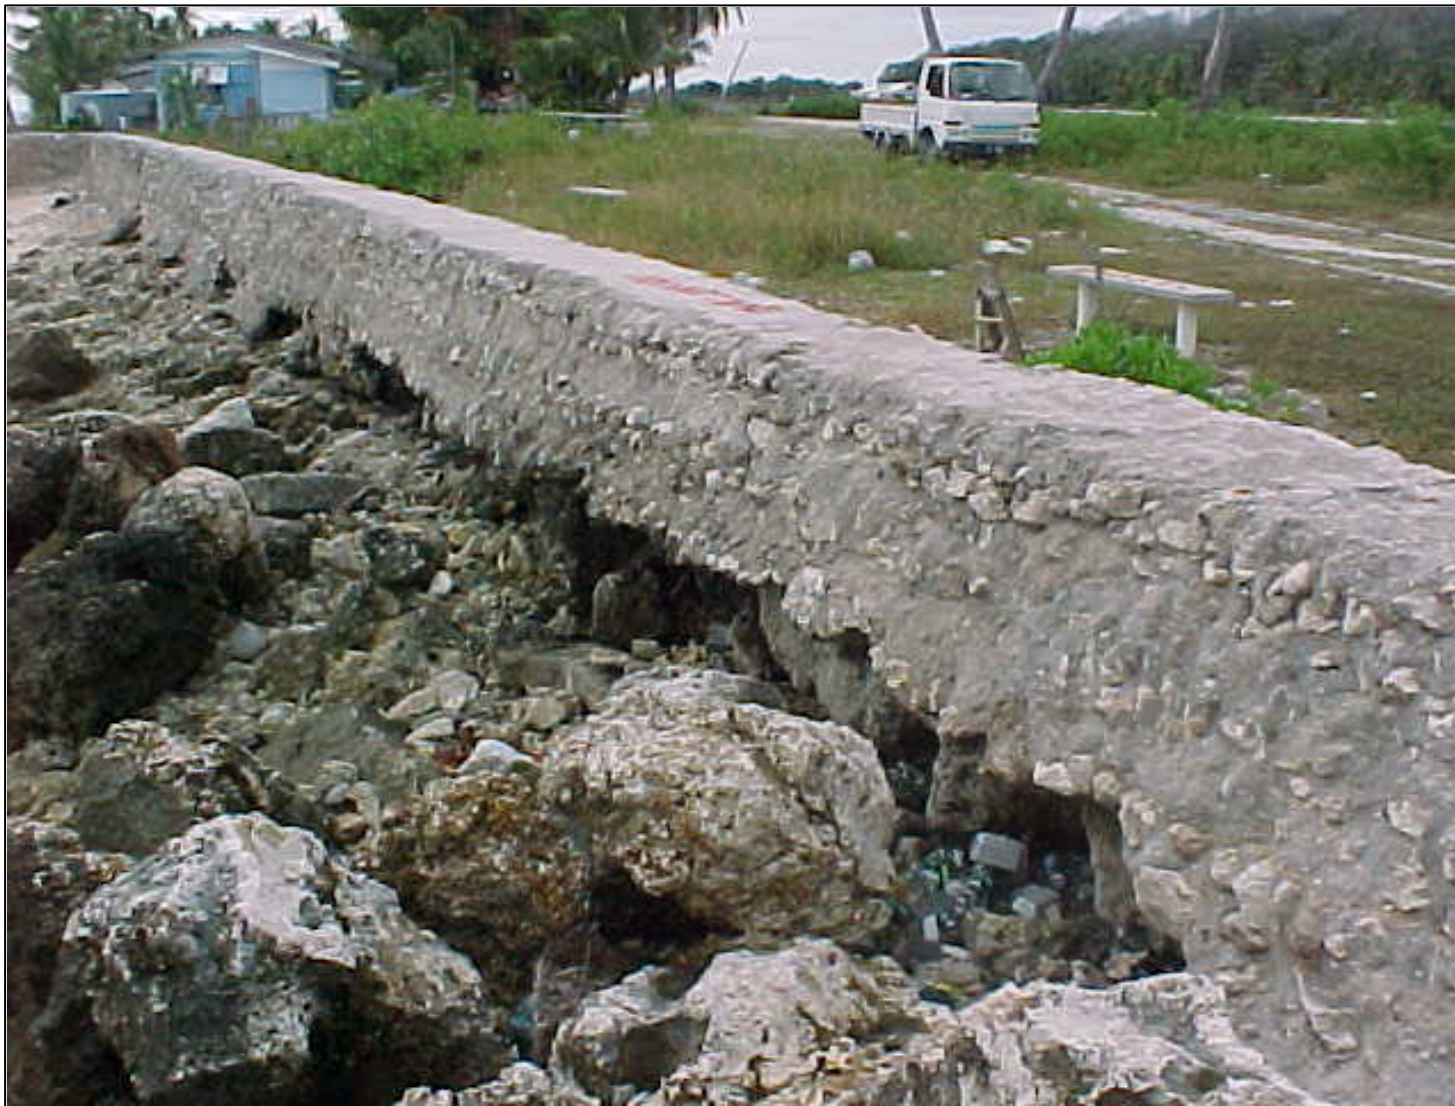
- Figure 18 shows basal scouring and undermining of the retaining wall shown in Figure 16;
- Figures 19-22 show large cavities in various sections of the masonry wall, produced by wave-induced erosion and scouring;

- eroded cavities like those above cause dislodgment of boulder aggregate from within the structure leading to loss of internal support;
- since masonry walls do not possess tensile strength, the wall eventually cracks due to loss of support and integrity and fails;

Figure 18. Basal scouring of the retaining wall in Figure 16.

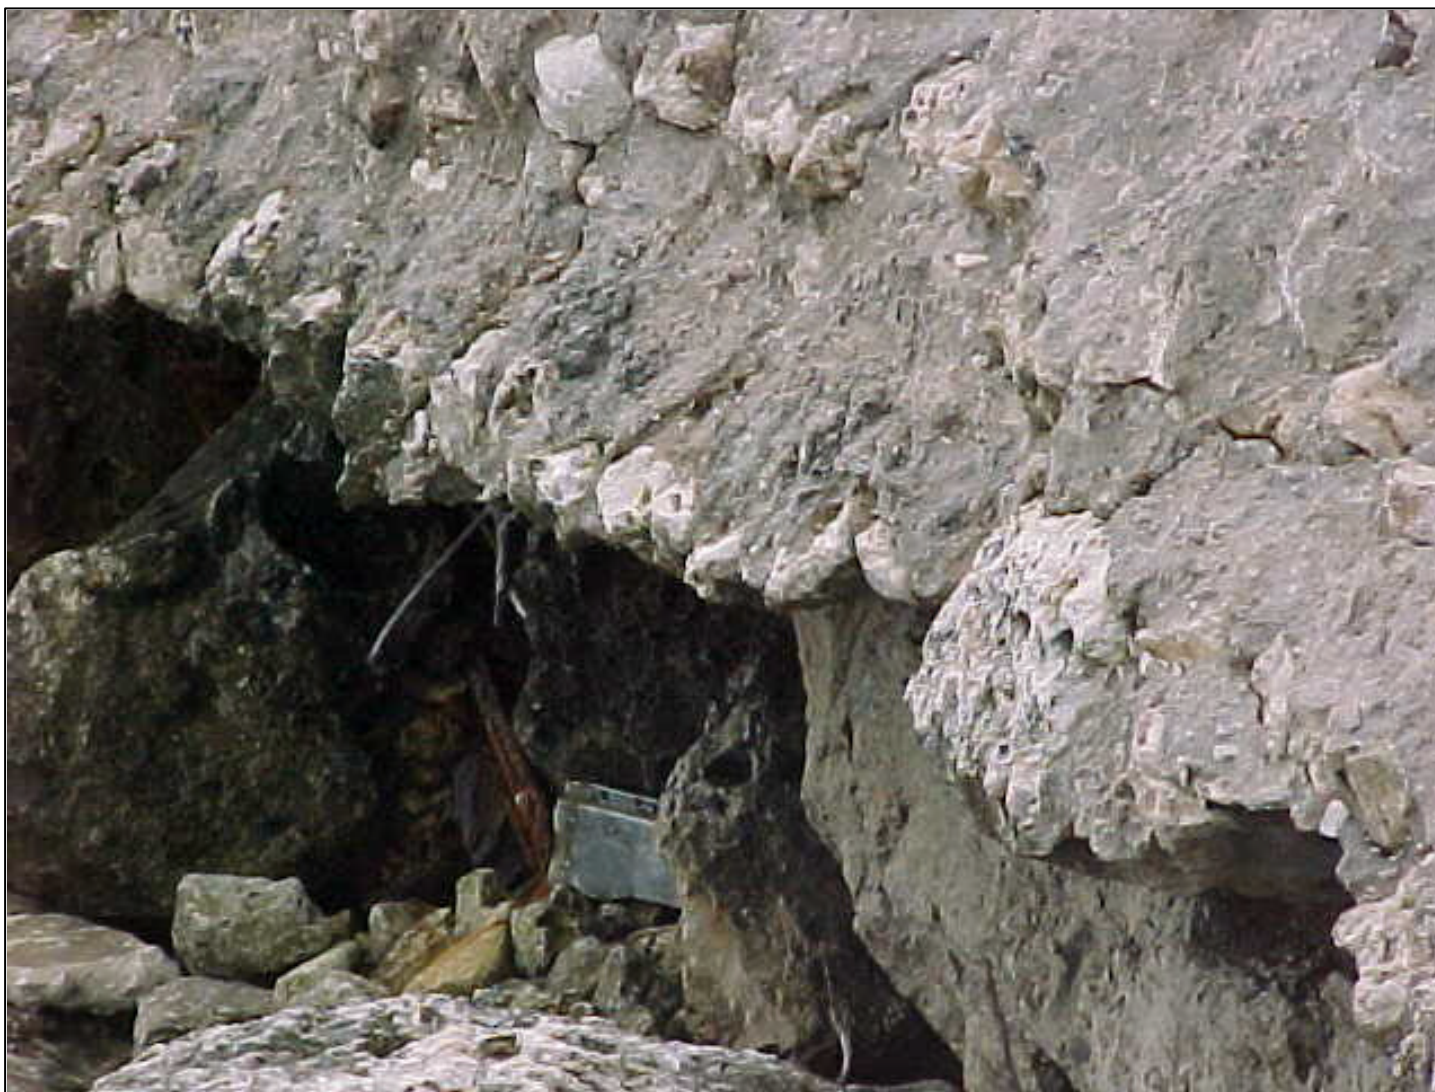
*Figure 19. Details of the scoured western section of the scoured retaining wall.*

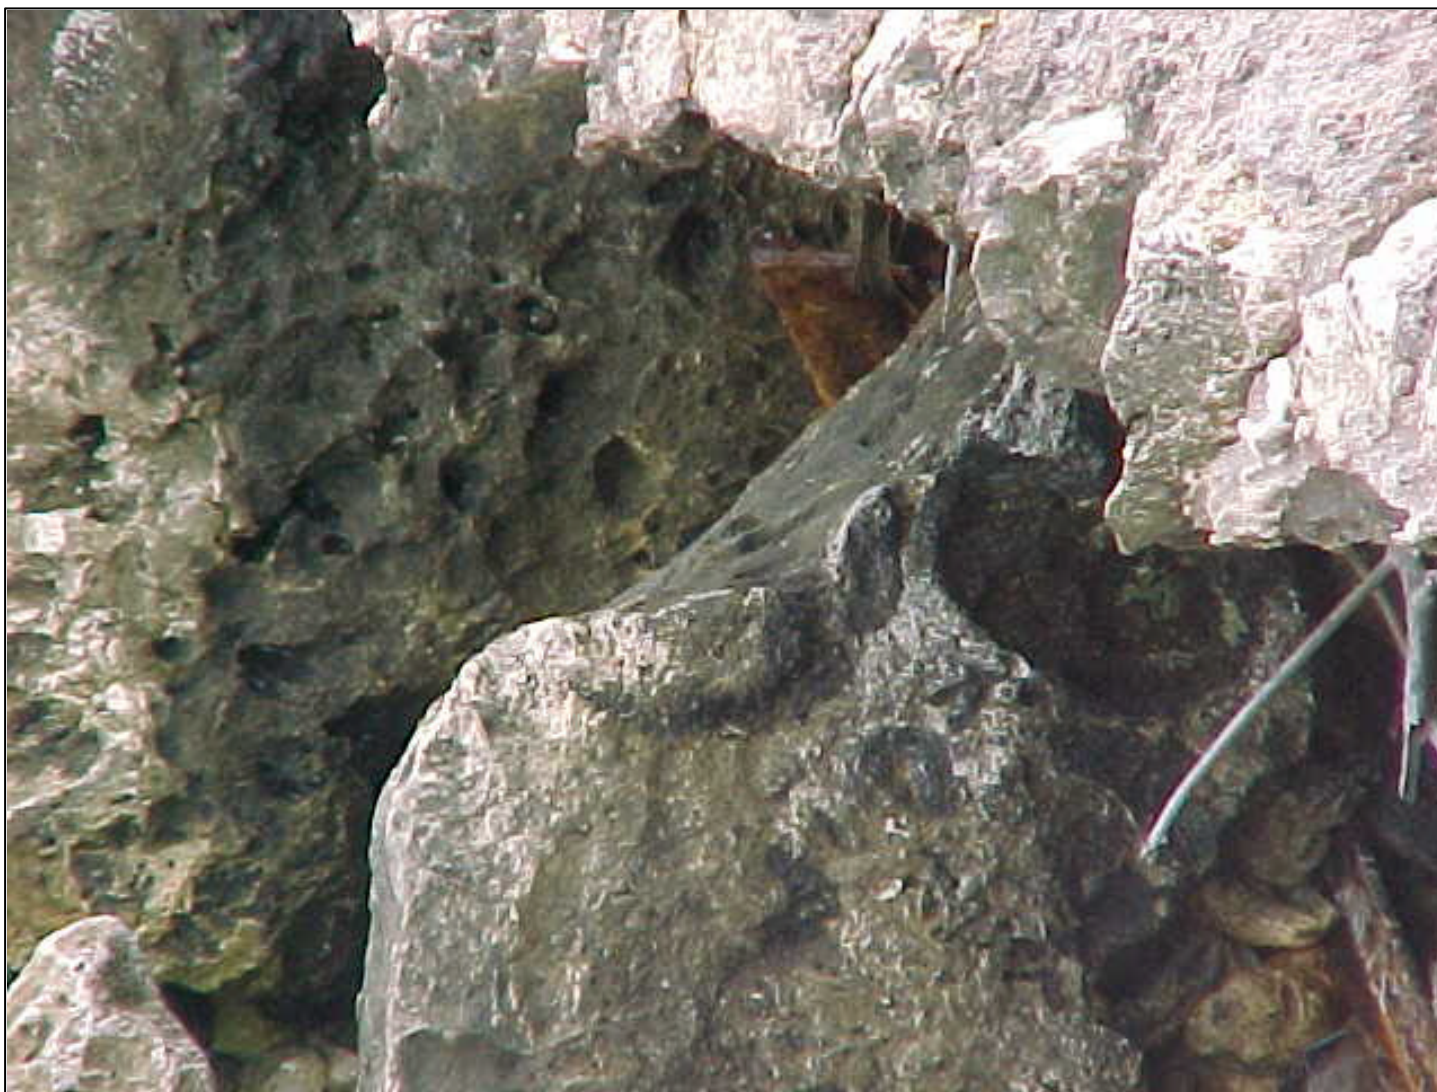
*Figure 20. Large cavities at the base of the scoured retaining wall.*

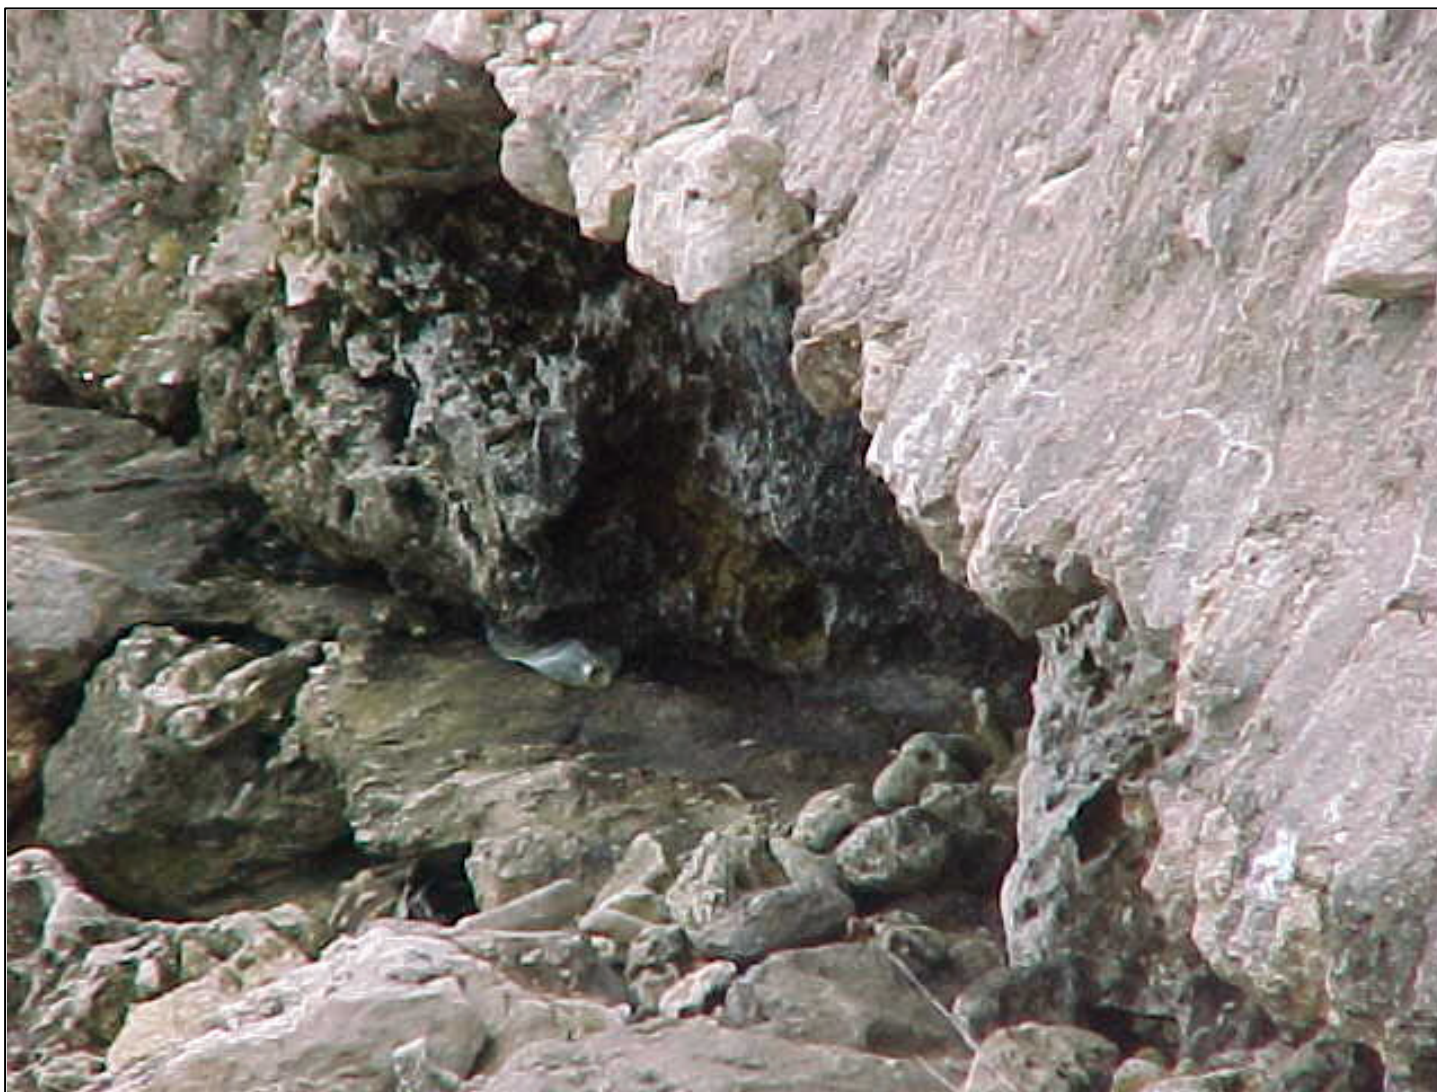
*Figure 21. Removal of boulder aggregate at the base of the retaining wall on the eastern side of the structure.*

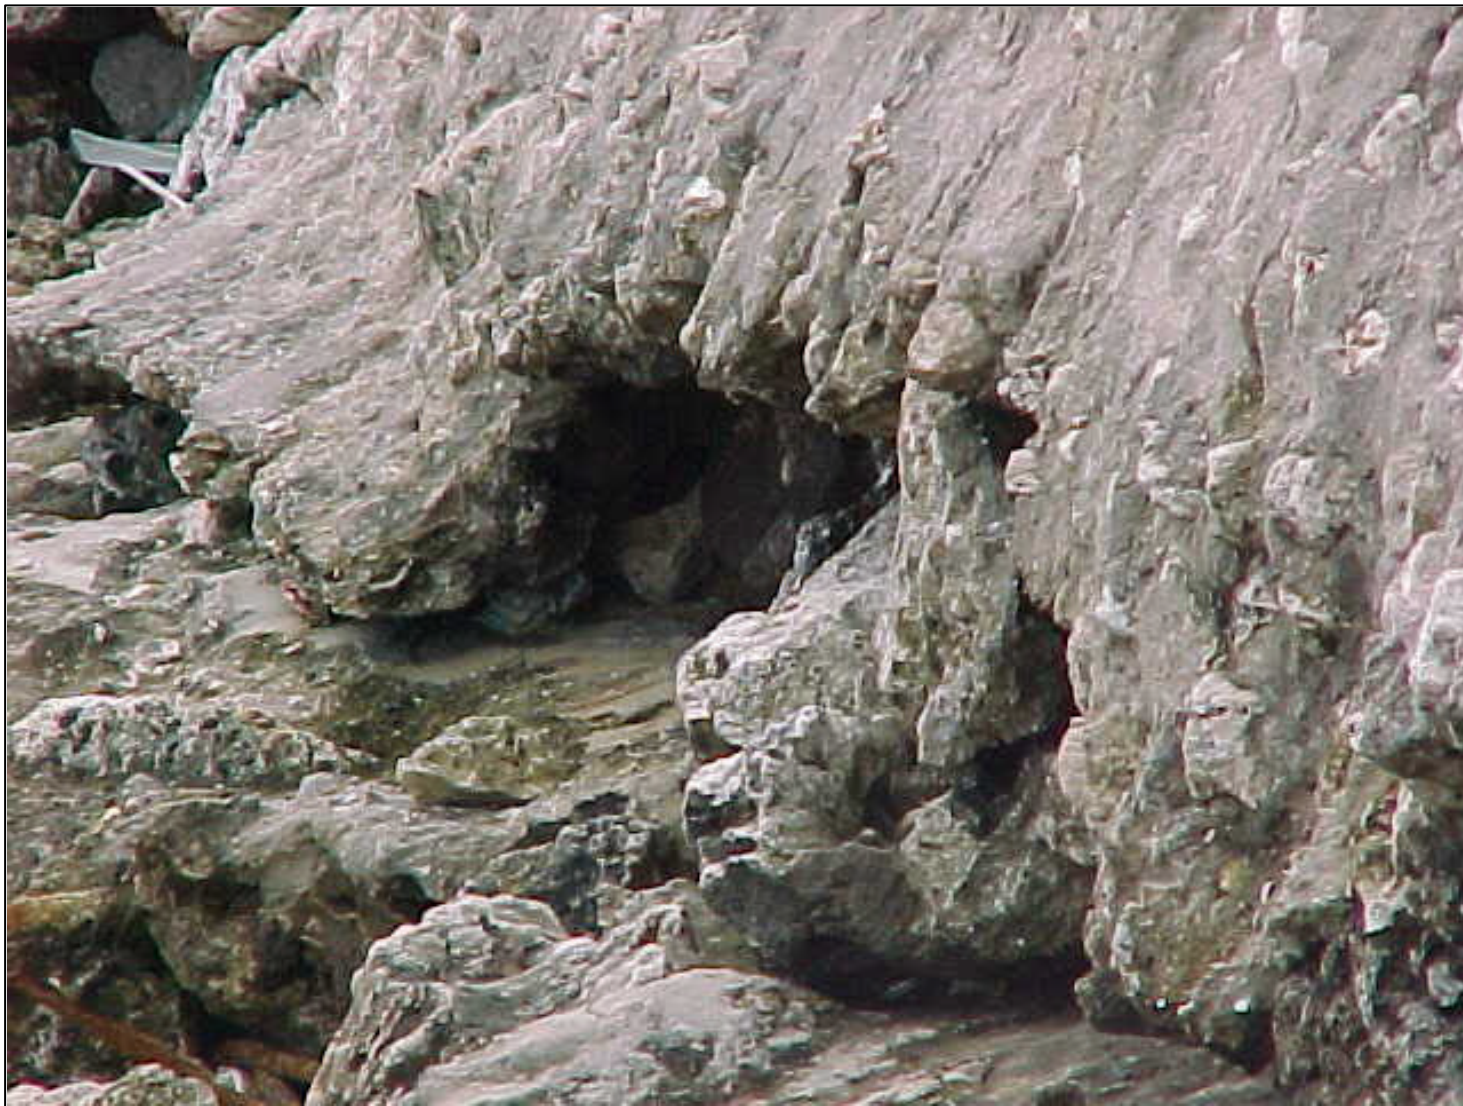
Figure 22. Scouring and removal of wall aggregate due to wave action and abrasion.
