# RECOMMENDATIONS FOR DESIGN OF A COASTAL PROTECTION SYSTEM FOR SHORELINE PROTECTION YAREN DISTRICT, REPUBLIC OF NAURU (RON)

May 2001

SOPAC Technical Report 317

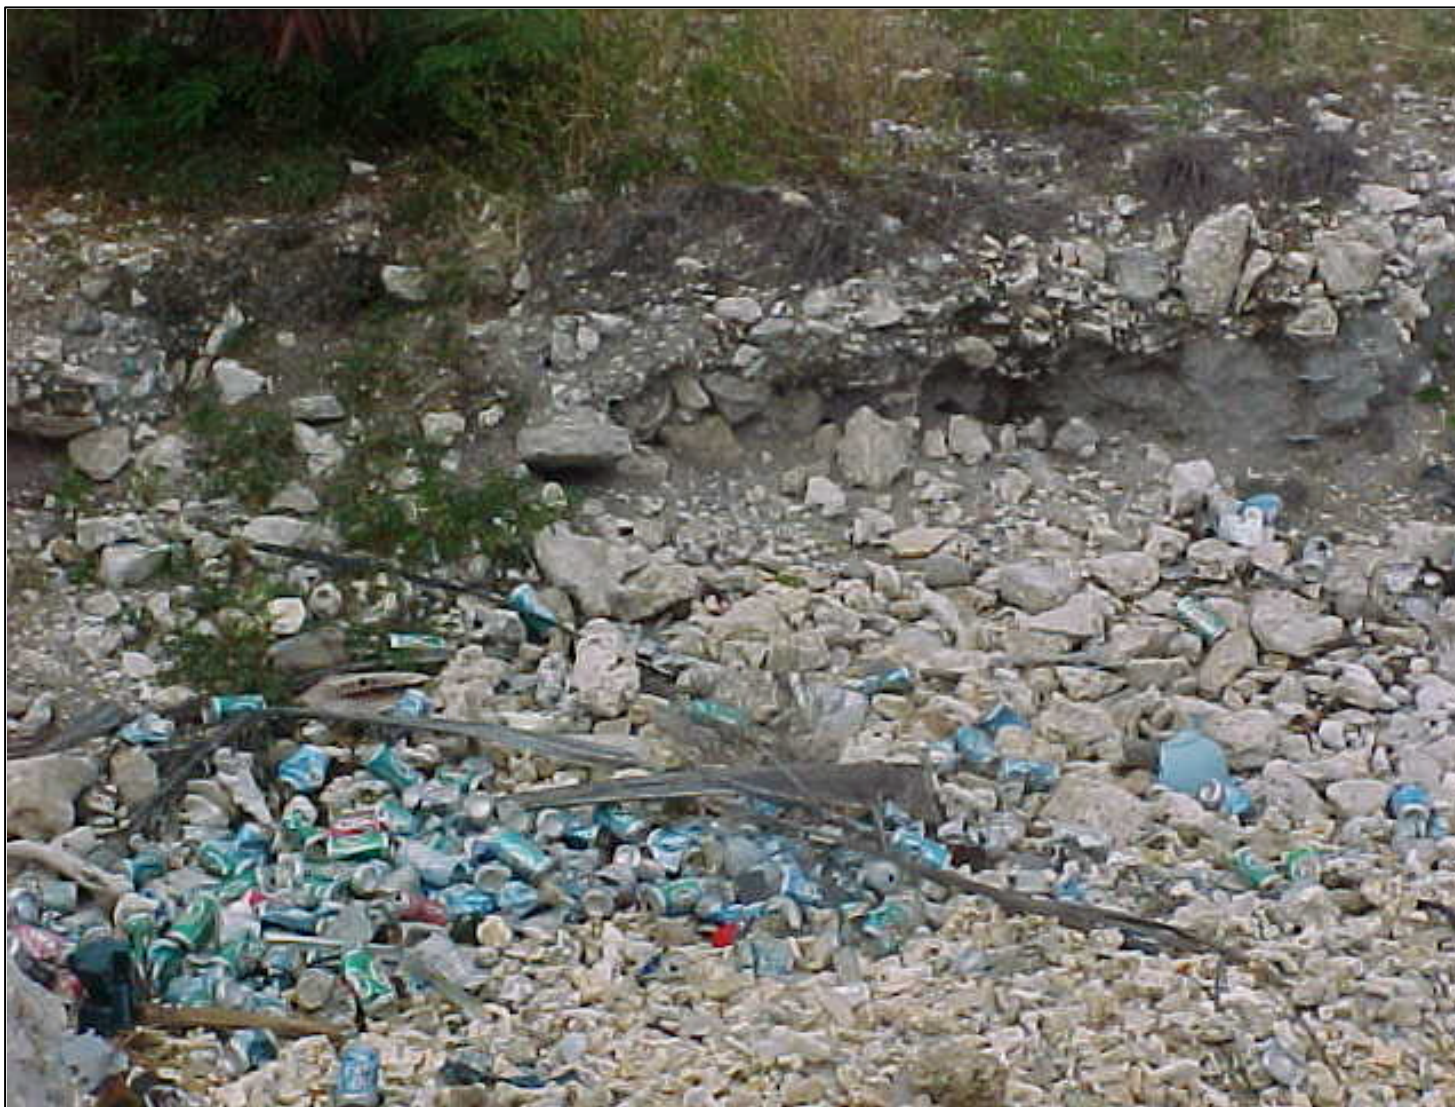
- the height of the scarp is about 0.75 m and exposes coarse, angular limestone fill material (Figures 24 and 25), with undercut sections (Figure 25);
- the entire fill site is contained by a slightly curved (at the top) concrete gravity wall (Figure 26), about 6 m above mean sea level;

*Figure 24. Details of the erosion scarp in Figure 23. Note dislodged gravel and small boulders.*

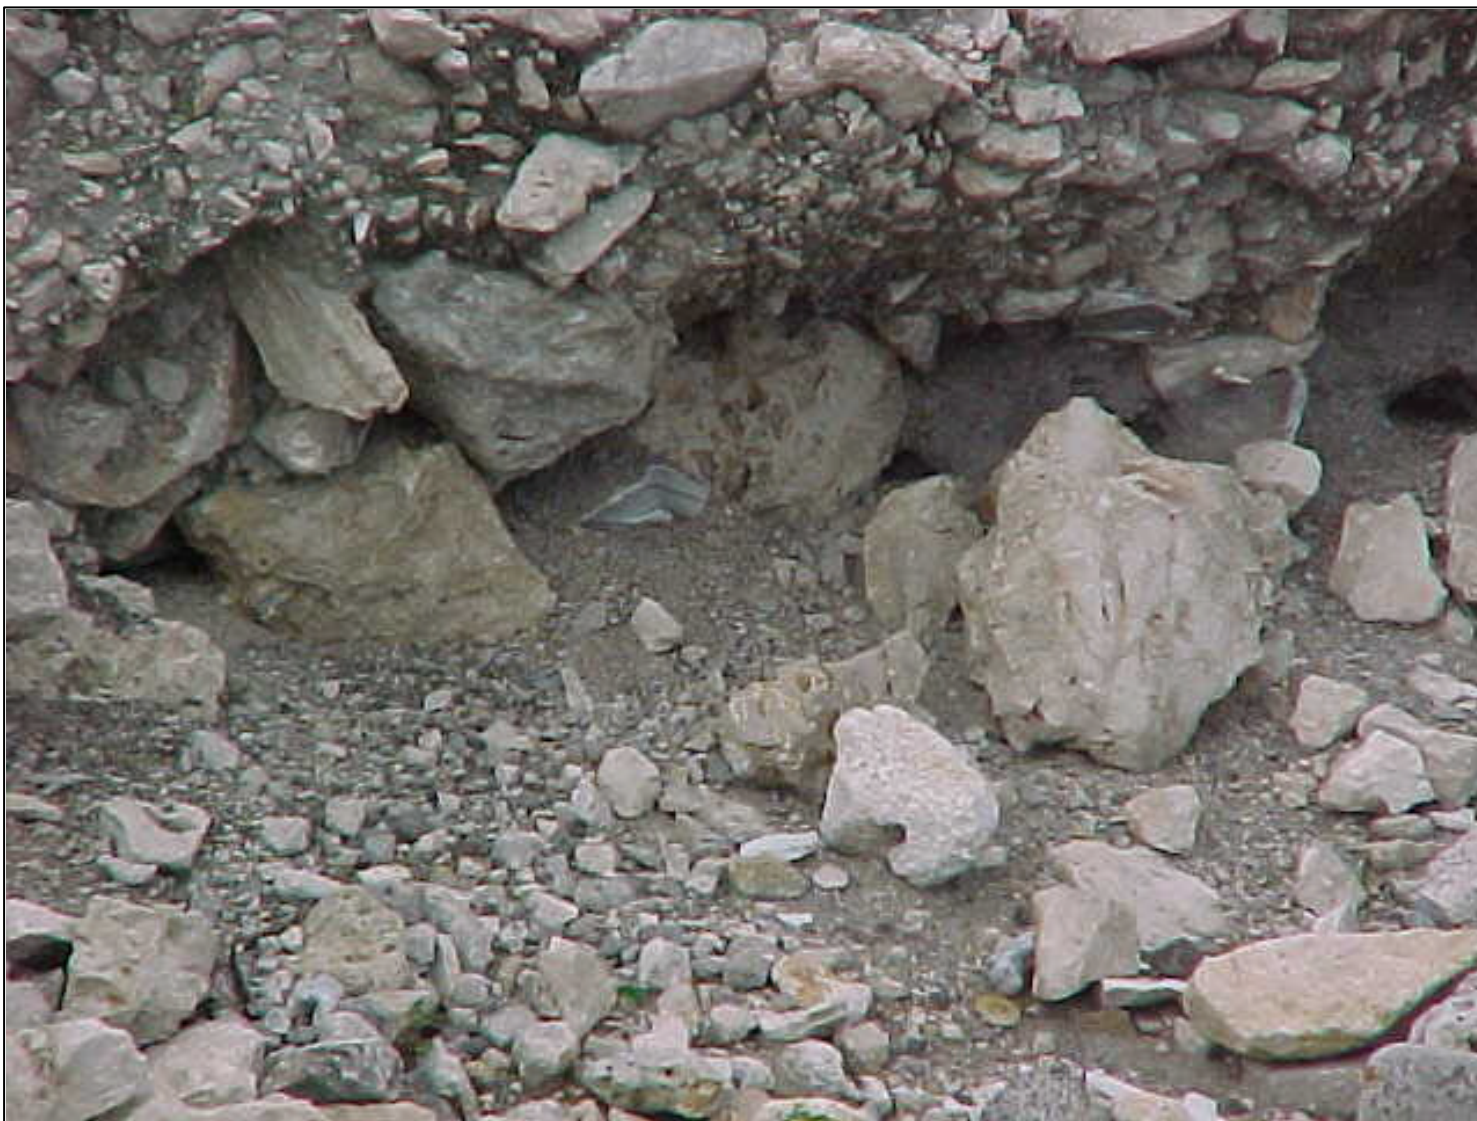
*Figure 25. Characteristics of the scoured area at the erosion scarp in Figures 23 and 24. Note the exposed aggregate fill.*

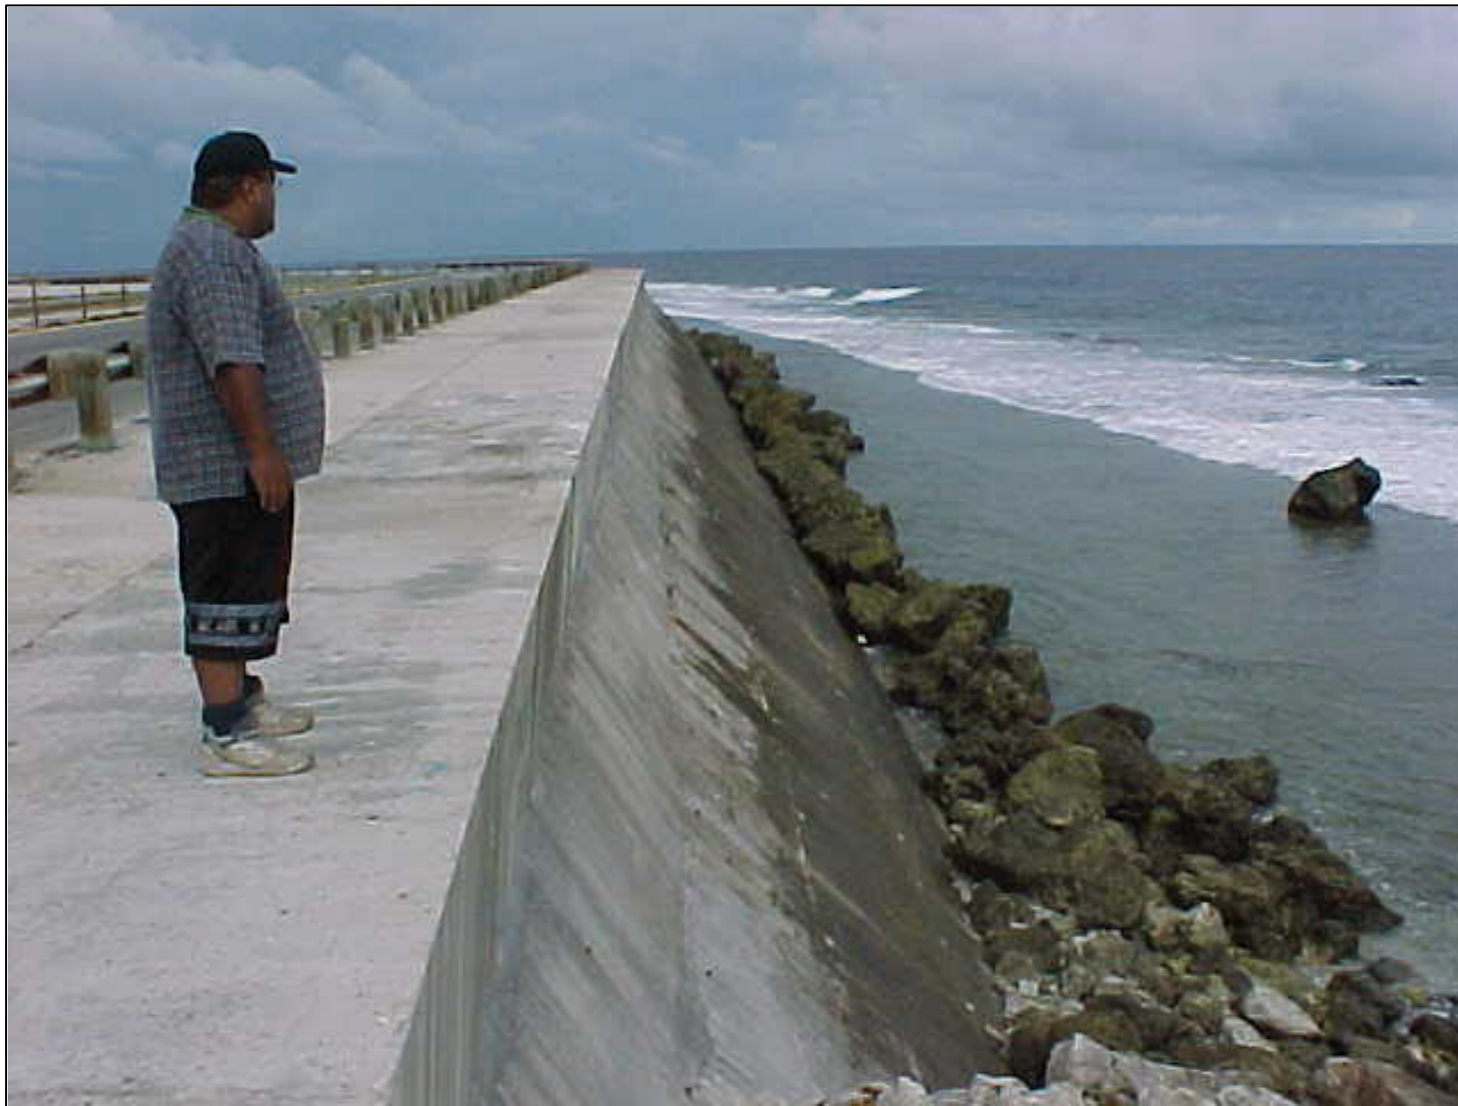
- the top of the wall is about 2.5 m wide;
- toe protection is provided at the base of the wall, in the form of 0.75-1.25 m diameter limestone rip-rap (Figures 26 and 27);

Figure 26. Gravity concrete retaining wall at the outer perimeter of the airport fill site. Looking east.
