EU EDF 8/9 – SOPAC Project Report 36:
Reducing Vulnerability of Pacific ACP States

TUVALU

TECHNICAL & COUNTRY MISSION REPORT –

ASSESSMENT OF AGGREGATE SUPPLY, POND AND LAGOON WATER QUALITY & CAUSEWAY CONSTRUCTION ON FUNAFUTI AND VAITUPU ATOLLS

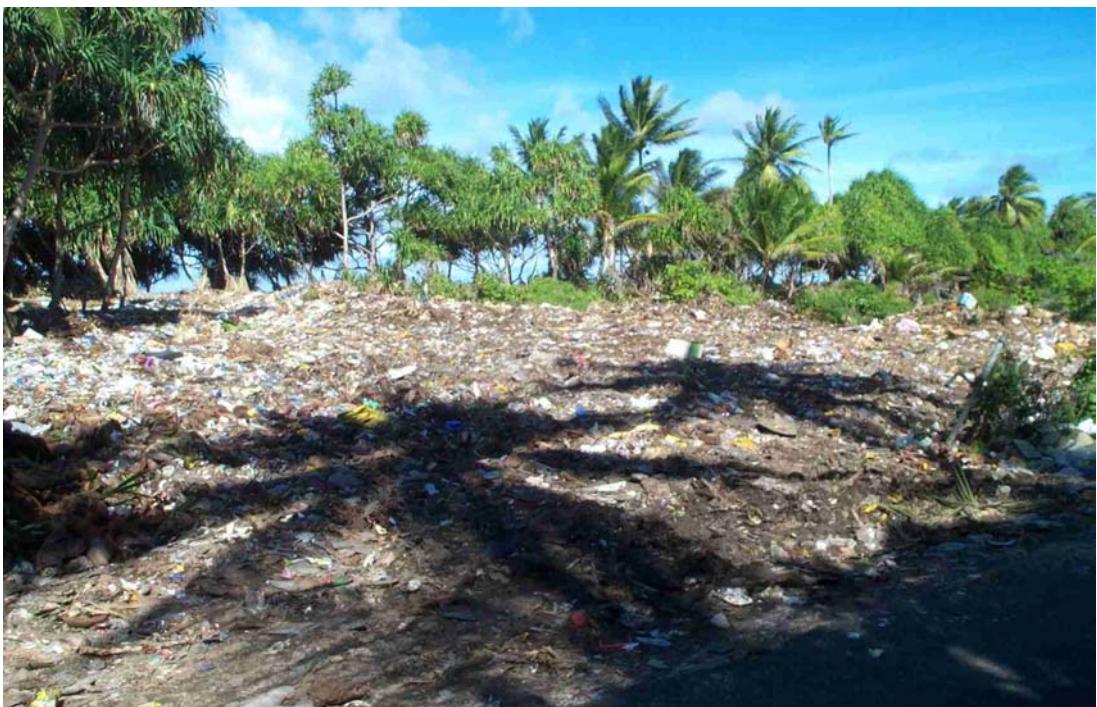
Figure 1. Fongafale waste collection site (old borrow pit) desperately requires capping material (some 2500 m³ of general-purpose fill is presently required to cap the landfill to 0.4 m).

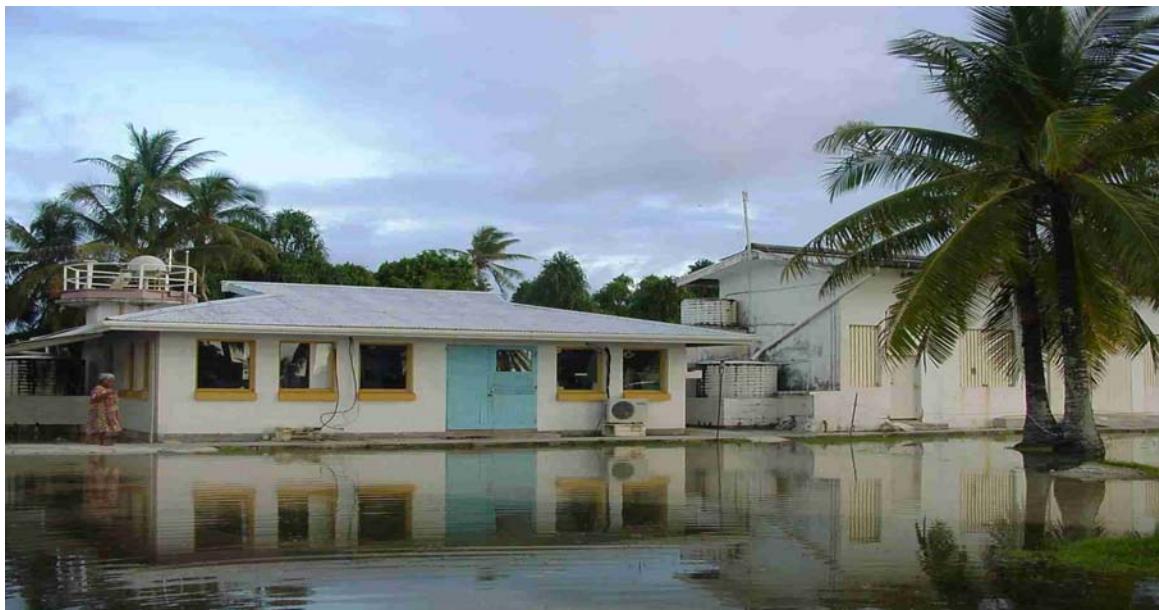
Figure 2. Funafuti Meteorological Office, inundated with seawater during spring tide conditions (tides > 2.8 m), the western side of the airstrip requires some 7500 m³ of fill to raise the surrounding area 0.3 m.

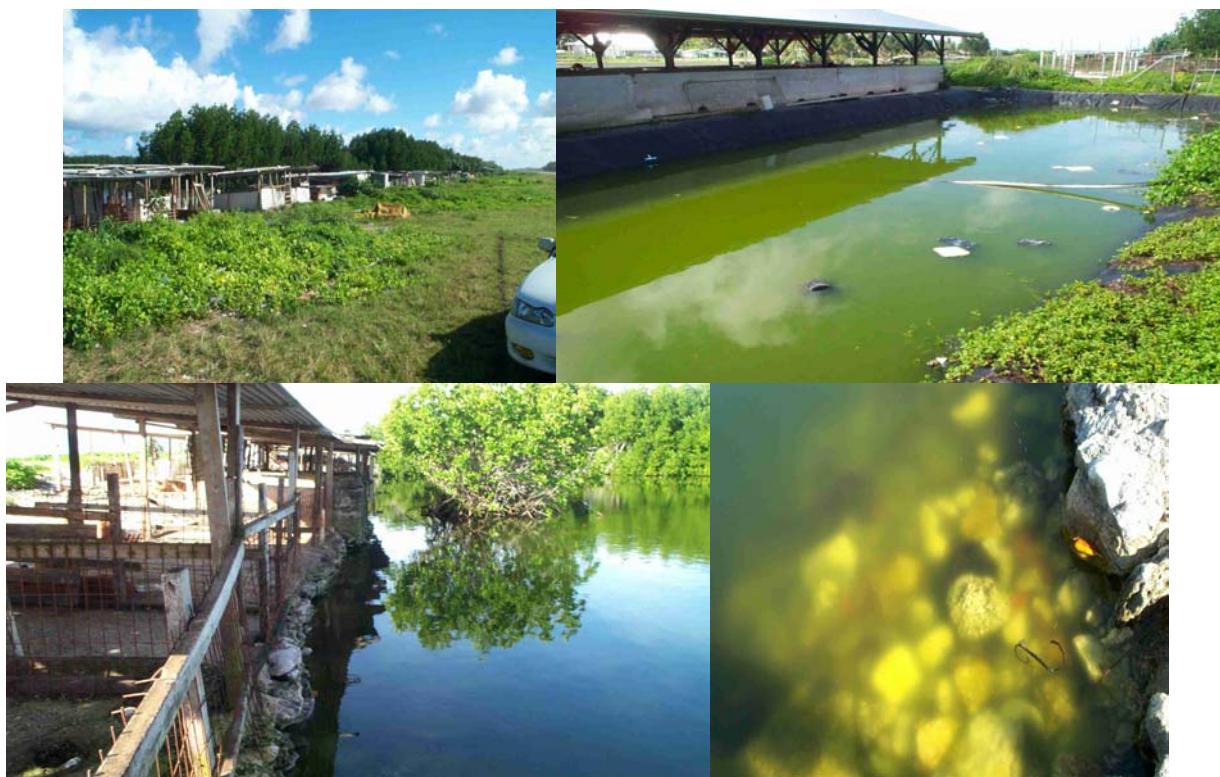
of the planned expansion of pig production on Tafua's shores. An incidental issue is the amount of enriched waters which are moving out of the pond, through the fore-dune and on to the ocean-side reefs adjacent to Tafua. Presently, no obvious signs of perturbation are evident and it is probable that in this high-energy environment problems may not arise due to dilution and flushing. Nonetheless, considering the expansion plans and the known intolerance of coral reef systems to increased nutrient supply (Mosley and Aalbersberg, 2002) monitoring of the reef is recommended.

Figure 4. Tafua pond (clockwise from top left) – Continuous row of pig pens on Tafua's western shore; AusAID piggery effluent treatment pond which overflows to Tafua; the proximity of pens to the pond on the north-western shoreline; and phytoplankton blooming on western side (green hazy tinge to the water colour).

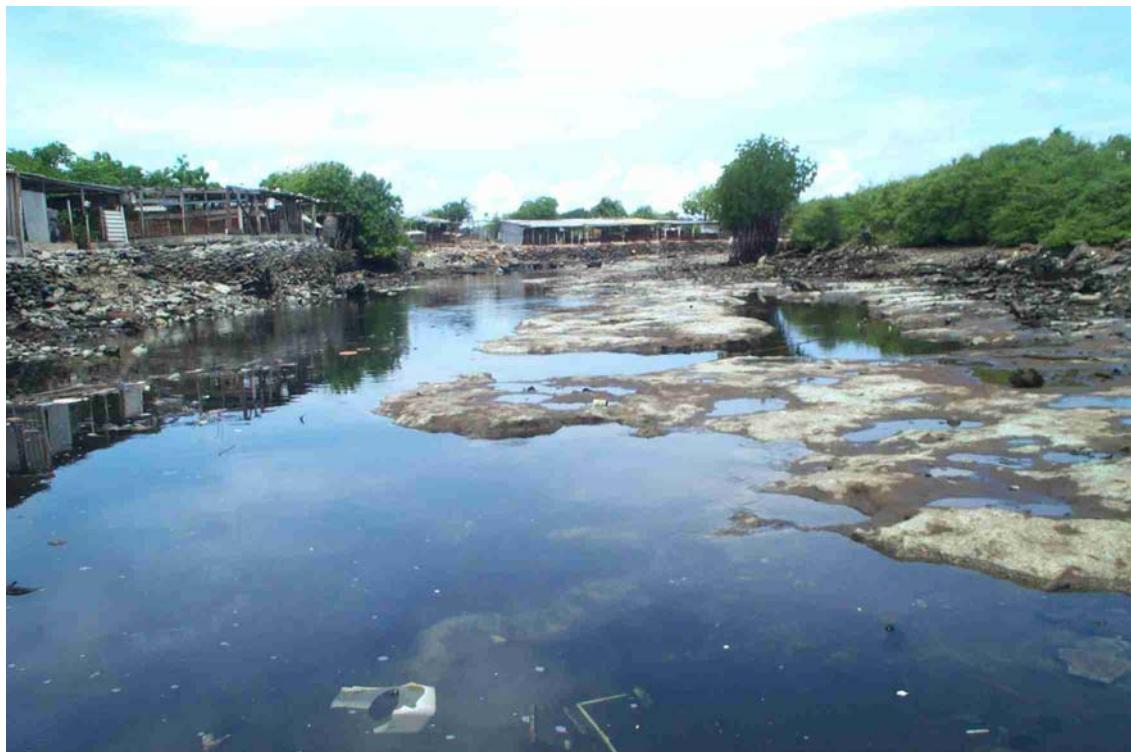
Some of the borrow pits have or are being used as disposal sites for domestic waste and these are considered no further due to the obvious conflict in use type. Otherwise, none of the other borrow pits seen appeared suitable for milkfish aquaculture. These pits dry out completely or become very shallow (10-20 cm) during low tides some with only a few small deeper holes available as a refuge for fish, these were small (probably less than 5 % of the pit area) and were all infested with tilapia (Figure 5). The water in such shallow pools may heat considerably during clear weather and temperatures above 32°C may cause stress in milkfish (*pers. comm.* Pickering 2004). To ensure adequate water remained in the pits these areas will either require sealing (so that water does not escape at low tide) or earthworks to deepen them. Both options would be very costly and even if this was undertaken the presence of tilapia will again require consistent management and on-going control measures if milkfish production is to succeed.

Figure 5. A borrow pit being considered as an alternative milkfish production site.

Funafuti borrow pits are not recommended as a viable option for milkfish aquaculture. It is likely however, that Tafua pond could be utilised for milkfish aquaculture but its success will be dependent on several factors:

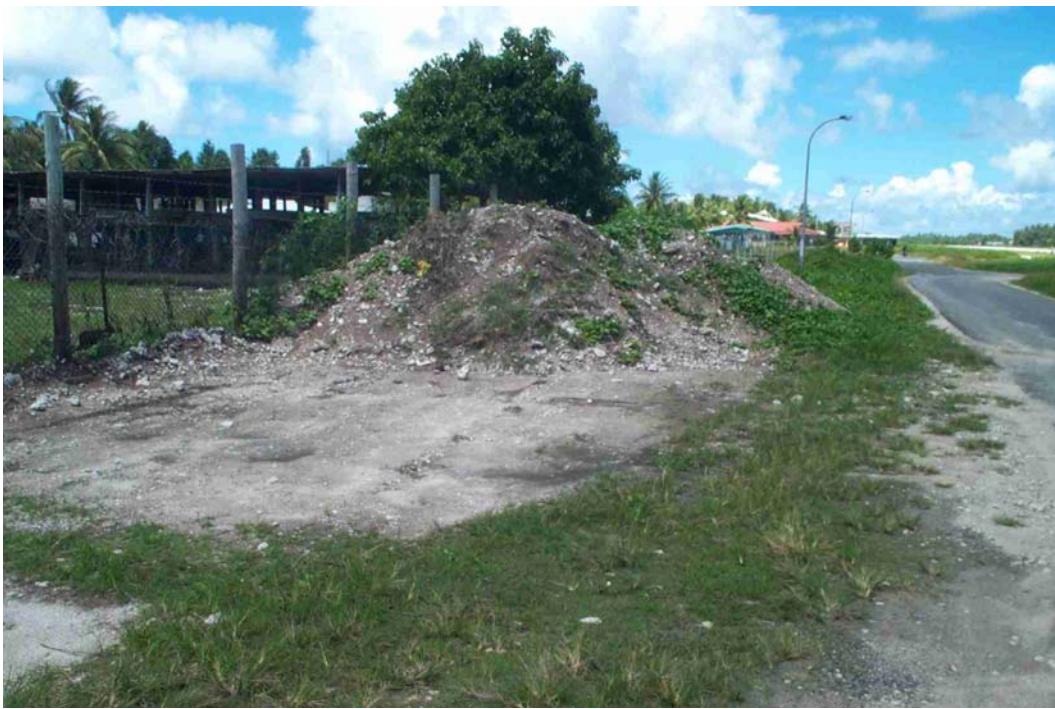
Figure 6. Present extent of PWD's aggregate stock pile.

The EU EDF 8/9 programme is well placed to provide information explaining the potential of off-shore aggregate extraction and it is recommended that an information seminar be drafted using resources and reports previously compiled by SOPAC and other organisations. This information combined with case studies from other island nations undertaking the exploitation of their off-

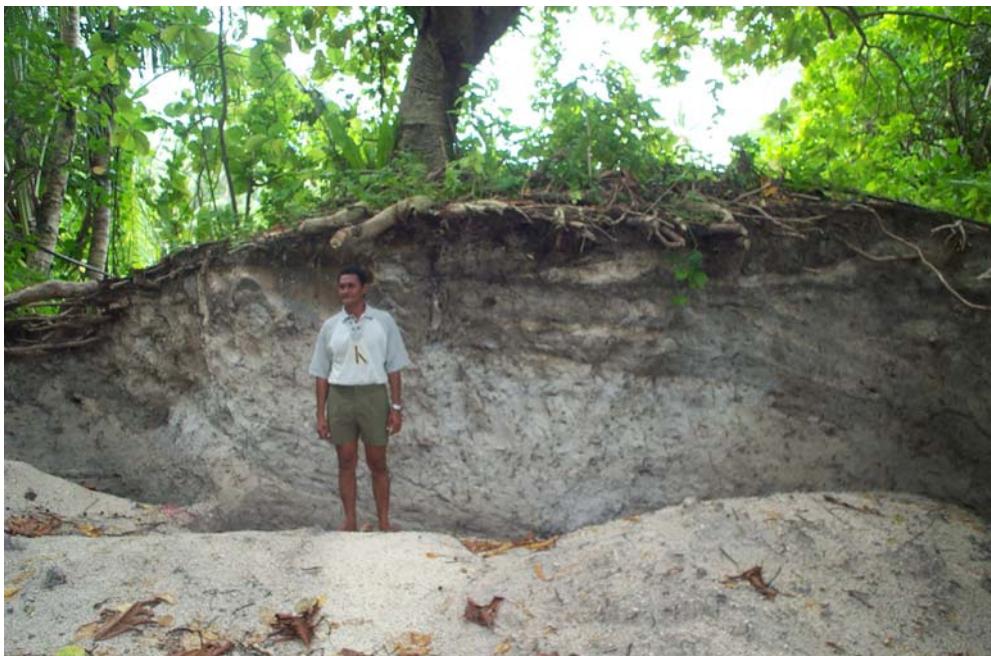
there seems few significant negative impacts. The beach is favoured as a gravel and sand collection site for private interests and larger-scale sand collection (by the Kaupule) has taken place at swamp taro pit spoil mounds (Figure 9). Some of these pits are many hundreds of square metres in area and over 1 m deep and the resulting spoil mounds are large. At present rates of consumption these will likely supply the community's needs for some years to come and their removal does not present significant environmental issues. Visual field analysis of these sands showed they were chiefly composed of coral and foraminiferal fragments, and were well sorted with a grain size predominantly less than 1.5 mm. These sands whilst useful for construction (concrete) do not form a good road base material as they do not readily compact and harden.

Figure 9. The spoil piles on the edge of large swamp taro pits (dug in pre-European times) are used as a sand resource.

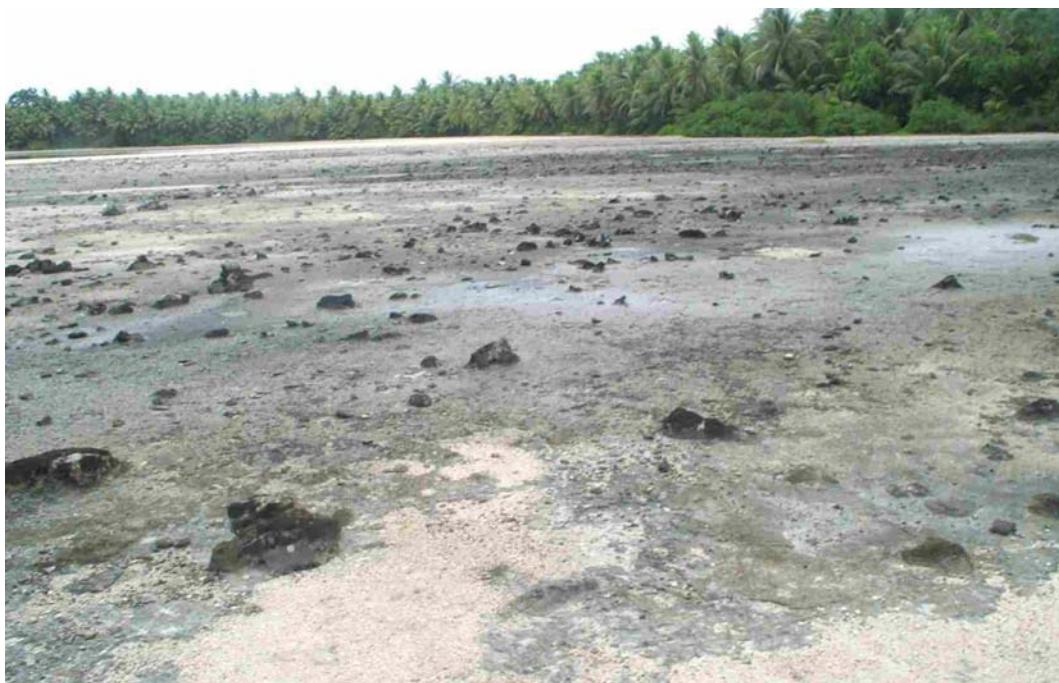
Sample site V2 (Figure 8) also corresponds to a proposed milkfish production site (No. 3 – Figure 8). Since milkfish production will require the digging of ponds in these intertidal sand flats, if this activity goes ahead, it could also generate a large amount of general purpose fill and road base which could be stockpiled and utilised by the Kaupule. These intertidal flats were comparatively extensive, were not vegetated nor were they extensively utilised by burrowing infauna (Figure 10). As such, from the sites assessed this area represented the least environmentally sensitive for both pond construction and road-base extraction.

Figure 10. Proposed milkfish production Site (3) in the northern lagoon area. Sediments from this area could also be used as a road base material and may be readily available if ponds are dug for milkfish production.

Of the three locations proposed by the Kaupule Site 3 is recommended as the other two locations perform important ecological functions for Vaitupu Lagoon (particularly if the causeways were removed). They are also vegetated and are home to numerous burrowing infauna (crustaceans, molluscs, etc.) and are already used as a food source by the Vaitupu community. Site 3 is comparatively barren and is more extensive in area, it also appears to have the potential to double as a source of road base which could be taken from the spoil heaps during pond excavation.

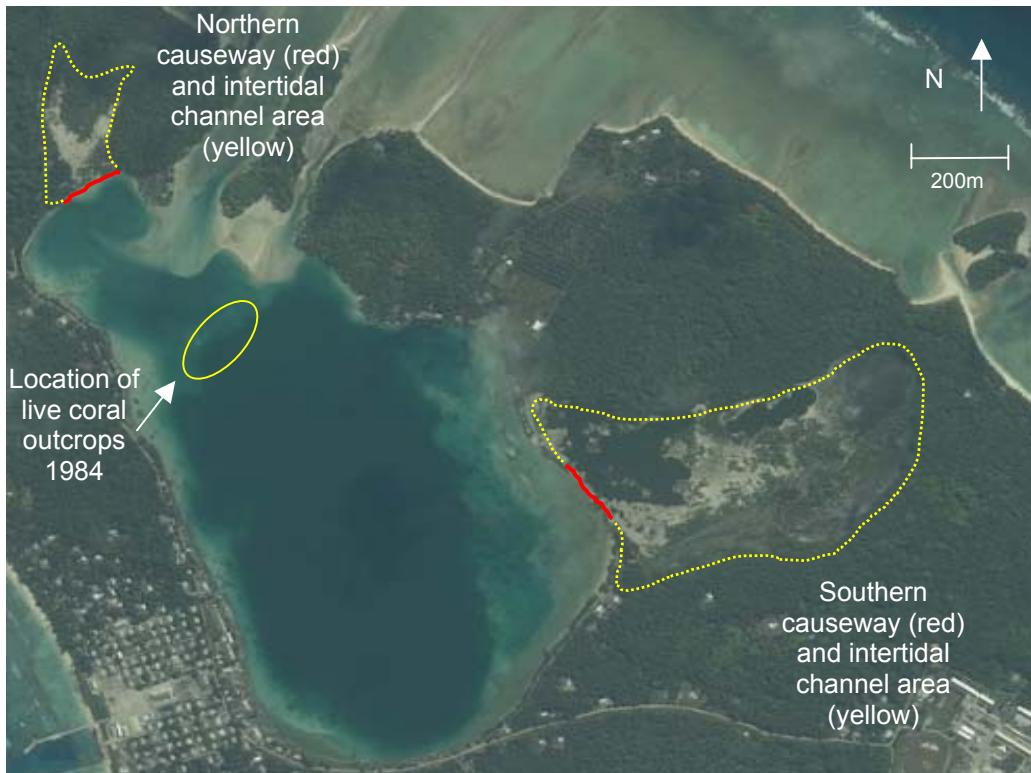
Figure 11. Water clarity in this 2004 IKONOS image of Vaitupu Lagoon is comparable to that of the 1984 airphotos and there is no indication of the lagoon becoming shallower particularly in the northern entrance area (the only significant source of transport into the lagoon). These mobile sand shoals at the entrance appear to have been surprisingly stable with few differences apparent between the 1984 and 2004 images. The absence of live coral is however evident in the northern area of the lagoon.

Figure 11 shows that large channels to the lagoon existed in fairly recent times at the SE corner and at the NE point of the lagoon. These intertidal areas are now separated from the main lagoon by causeways, which allow only limited marine water to move into the low-lying channel areas at high tide. Dense mangrove stands (*Rhizophora stylosa*) and ironwood thicket (*Pemphis acidula*) dominate the southern low-lying area and in earlier times (presumably before the causeway was built) it was valued by the community as a milkfish fry refuge area. The northern relict channel represents a similar habitat and likely preformed a similar function however, the vegetation is presently dominated by ironwood as marine flushing is possibly inadequate to support mangroves. When open, these intertidal flats may also have performed a significant biochemical “cleansing” function of the lagoon waters (nutrients being removed by benthic algae and macrophytes during high tide) and elsewhere similar environments are known to be the sites of high productivity and drive important food-chains (Webb, 2003).

The causeways across both the north and south eastern channel areas should be either removed or large sections replaced with a pier and platform bridge structure. This will allow less restricted water flow into these areas and in time the recovery of their ecological function and importance to the lagoon ecosystem.

It is also important to understand that whilst it is recommended that the existing causeways over the relic channels in the lagoon be removed (Figure 11), the removal of these causeways will increase the water volume of the lagoon and as a result, the velocity and volume of water which will move through Tefota or Aua Opeti Passages. As such, the maintenance of unrestricted flow through the channels will be of even greater importance.
