# RECOMMENDATIONS FOR DESIGN OF A COASTAL PROTECTION SYSTEM FOR SHORELINE PROTECTION YAREN DISTRICT, REPUBLIC OF NAURU (RON)

May 2001

SOPAC Technical Report 317

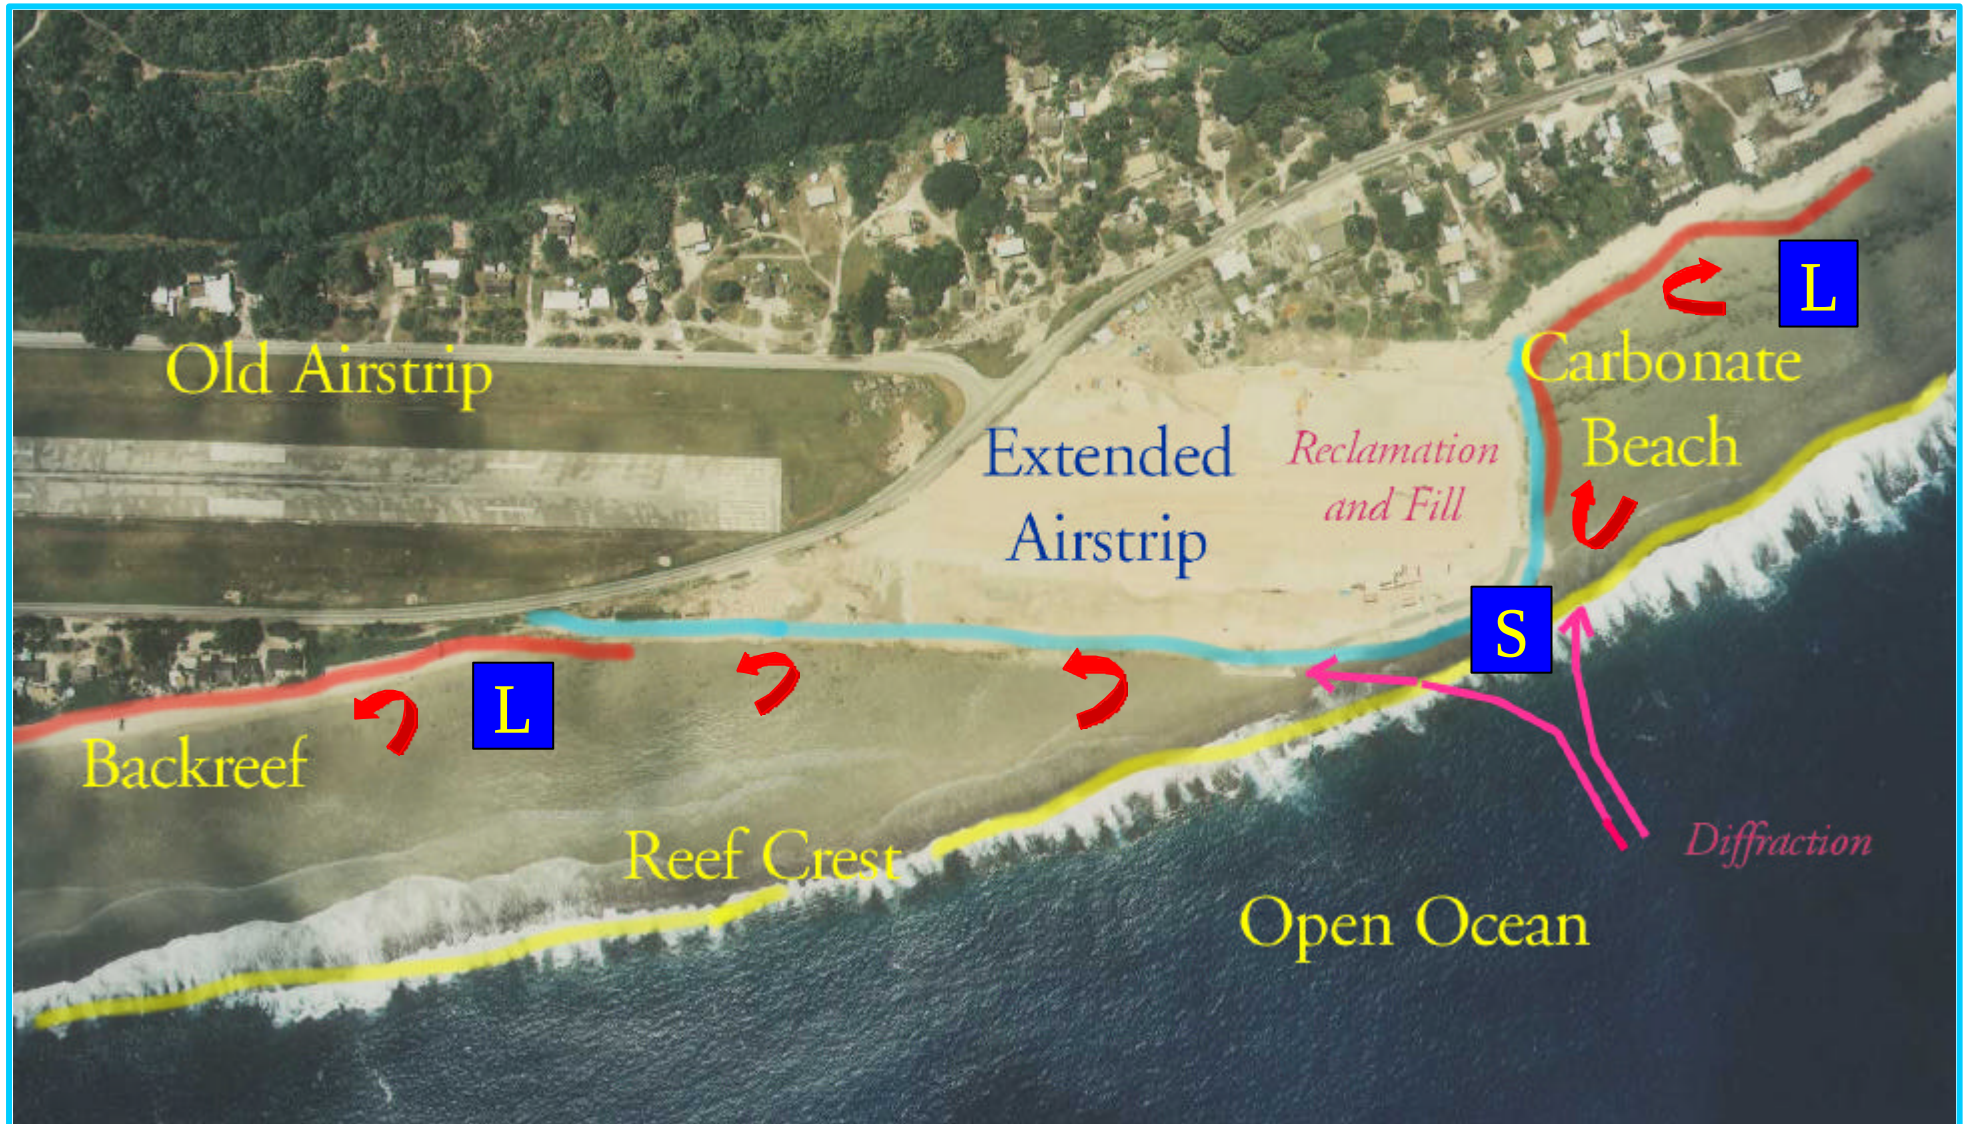
- waves approaching the problem area diffract around the airport extension reclamation and fill site, shown in Figure 3;
- diffraction is to both the east and the west (pink arrows; Figure 3);
- diffracted waves cause longshore currents (L; Figure 3) to be generated in opposite directions, from the seaward-most part of the reclamation and fill site (S; Figure 3);
- this causes longshore currents to flow both to the east and west of the fill site;
- both longshore currents are more significant at high tides, especially EHWST, when waves are larger and the

- water depth (effective submergence) is greater in the area;
- both longshore currents cause erosion points to develop (from point S; Figure 3) on both sides of the reclamation/fill site;

- these have caused loss of fine, loose and cohesionless carbonate sands and gravel from beaches to east and west of the airport extension site (S; Figure 3);

- the loss to the west has been greater than on the east, as longshore is dominantly to the south, reducing scouring to the east;
- longshore currents generated by these diffracting waves cause significant removal of beach sediment along the coast, at the problem site (areas in red; Figure 3); and

Figure 3. Location of Yaren District, the eroding coast (red), the reef areas and adjacent reclaimed and filled new section/extension of the airstrip. L-longshore current; S-seaward part of fill site.

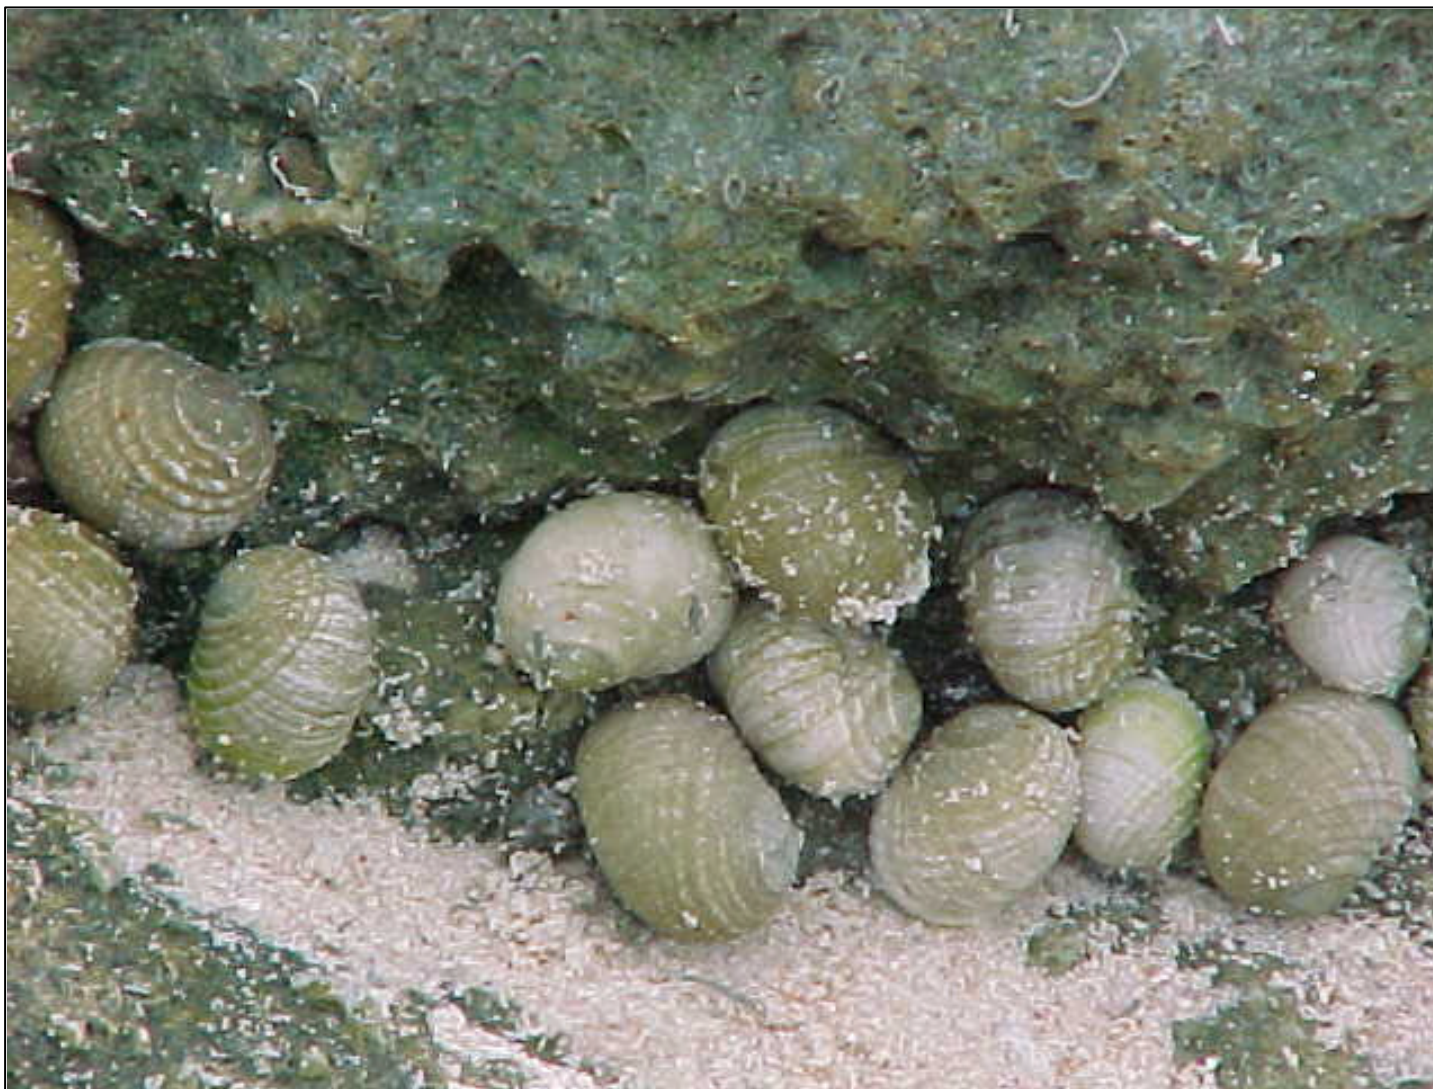
Figure 11. Molluscan fauna on limestone substrate on the lower beach.

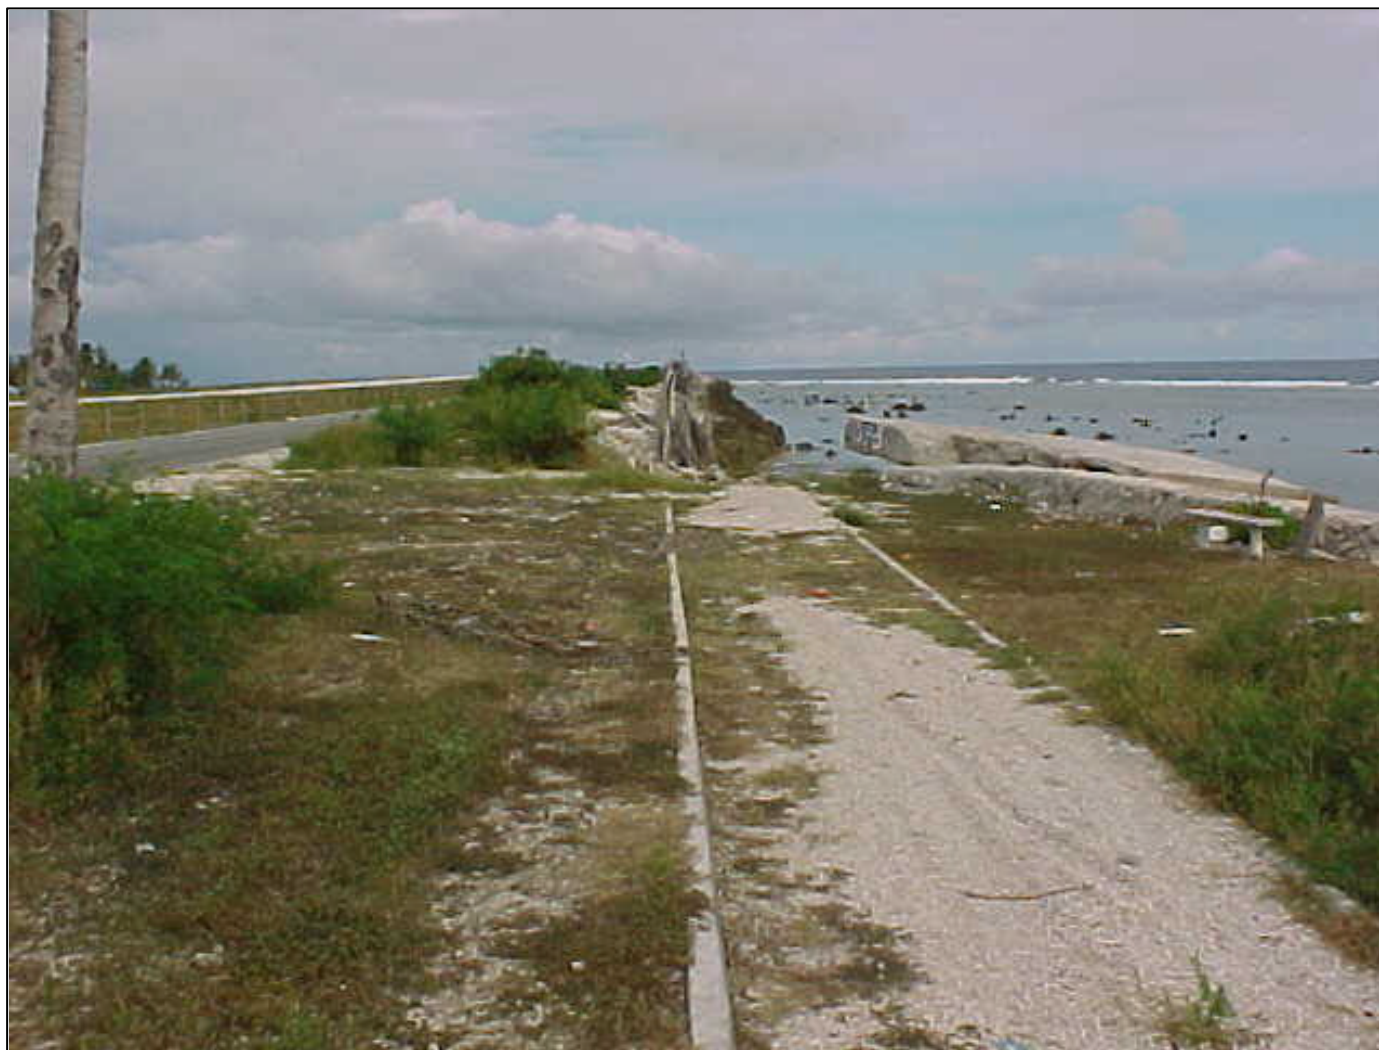
- Figures 13 and 14 show the airport reclamation and fill site;
- note the rip-rap revetment protecting the reclaimed site (Figure 15);
- the rip-rap is made of dolomitic limestone from Nauru;
- note also the green brown algae covering boulders in Figure 15;
- Figure 16 shows part of an old, almost vertical (85°), 1.65 m high and 0.75 m wide (at the top) masonry retaining wall at the problem site. Note strewn 0.30 m diameter, limestone boulders from damaged wall sections (also Figure 17);
- sand and fine gravel are deposited between boulders;

Figure 13. Location of the airport fill site.

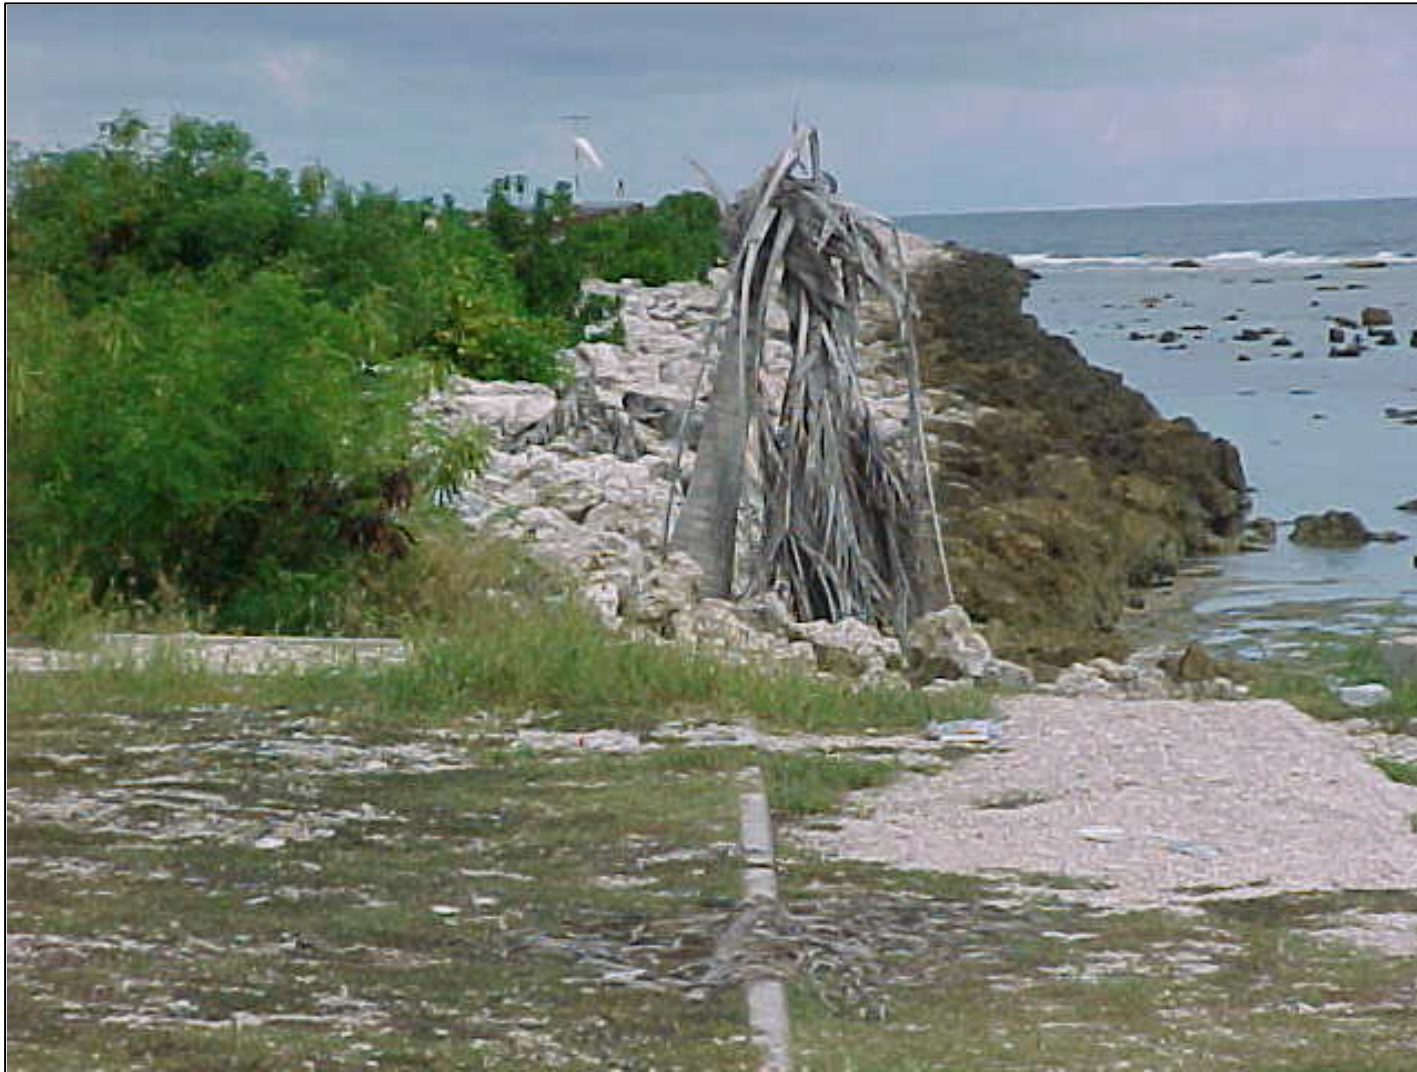
Figure 14. Details of the fill protection using rip-rap revetment.

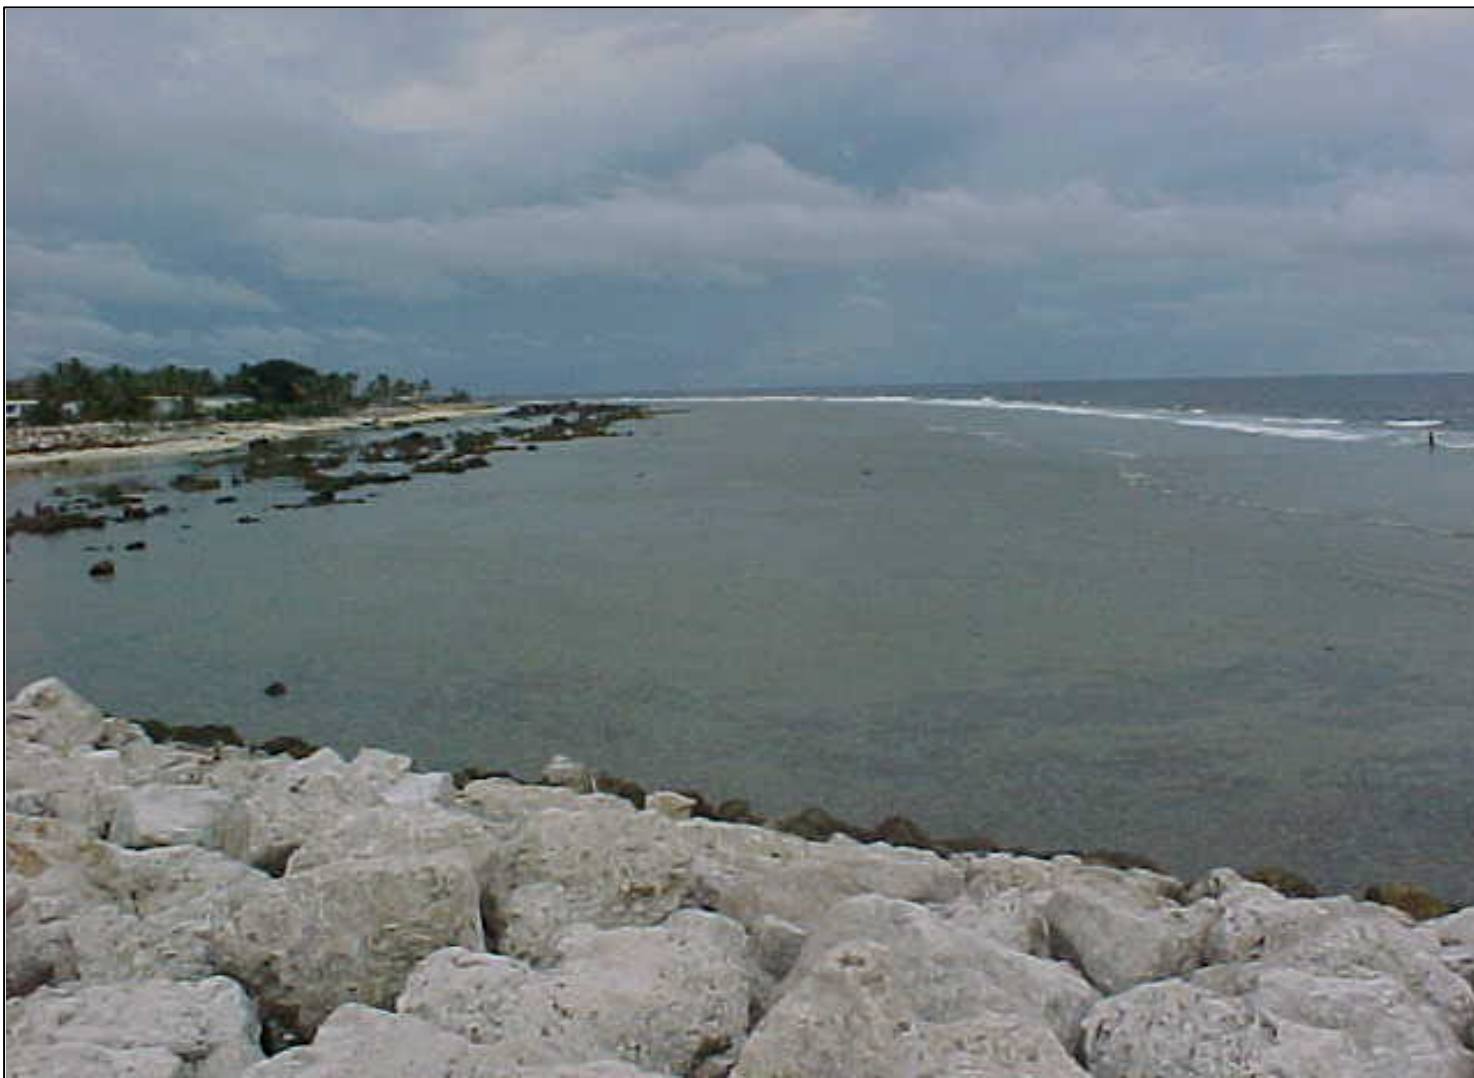
- toe rip-rap may occasionally be dislodged by large waves and during extreme events (Figure 27) and therefore not entirely stable;
- Figures 28-30 show some features of the eastern part of the coastal rip-rap revetment at the airport fill site;

*Figure 28. View looking east of the coastline at the airport fill site. Note rip-rap in foreground.*

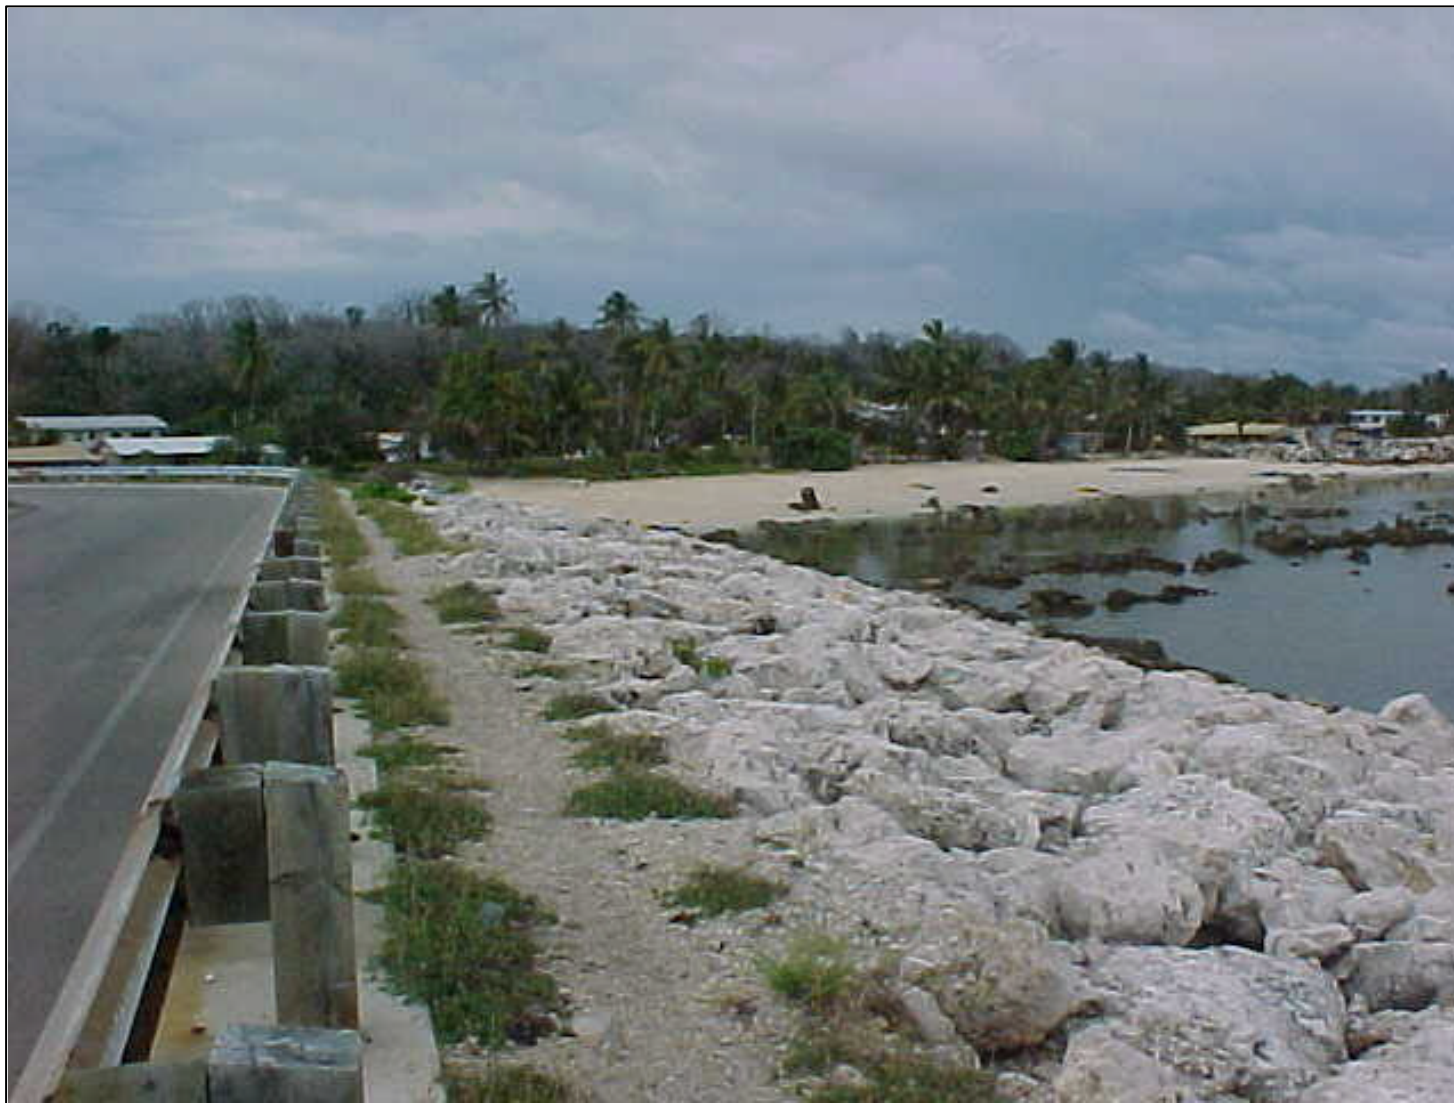
Figure 30. View looking north-northeast showing the rip-rap revetment protecting the airport and coastal roadway. Note limestone pinnacles in the surf zone (to the right).
