# Kosrae Shoreline Management Plan

Repositioning for resilience

NIWA Client Report No: HAM2013-133  
Report date: November 2013  
NIWA Project: DGI13201

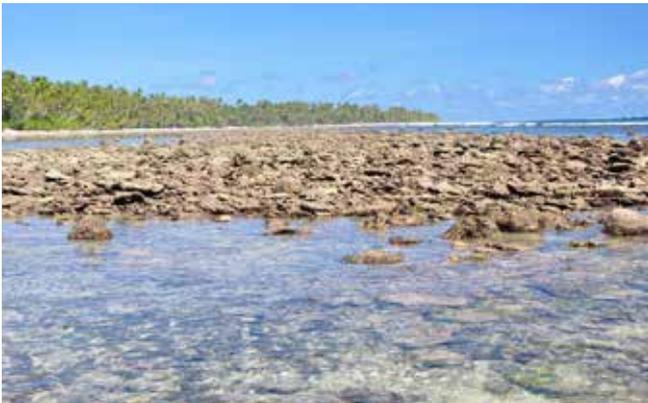
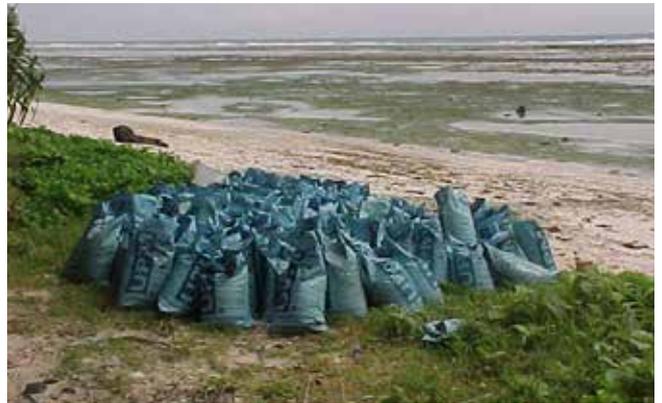
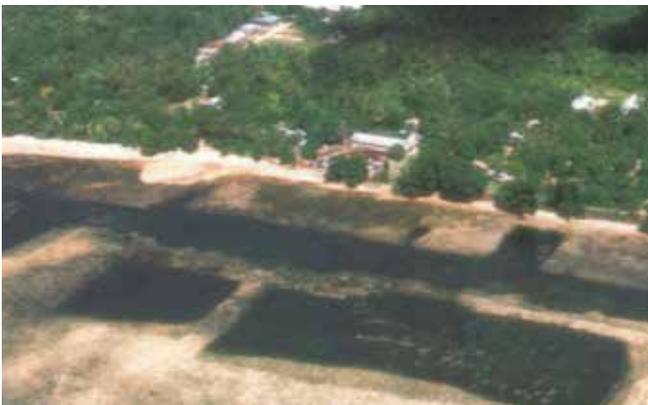
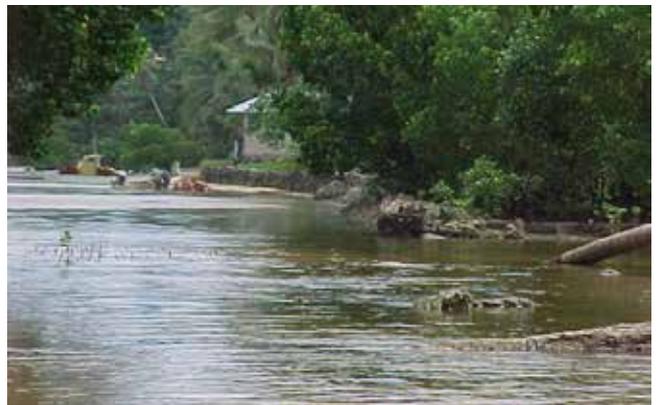
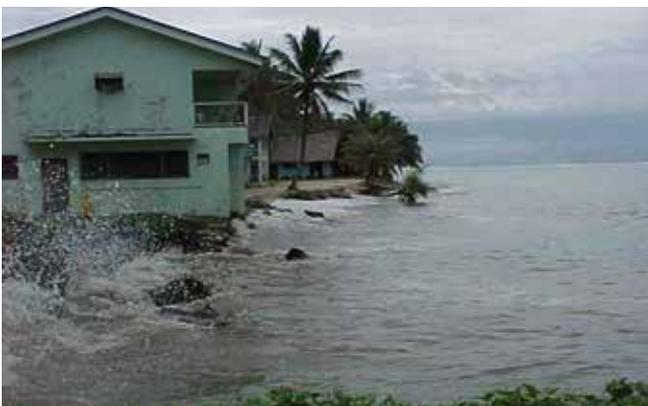
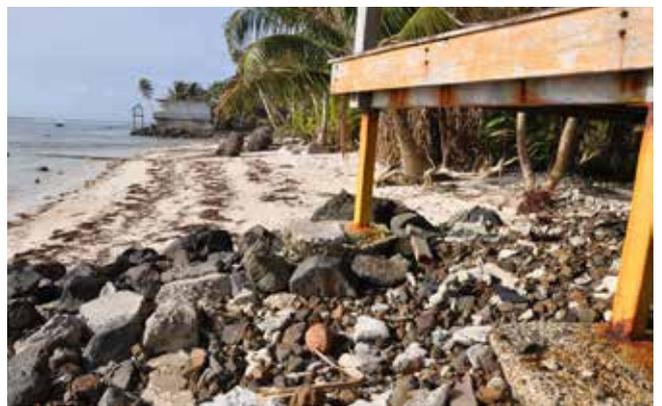
Figure 4: Examples of human impacts that have caused or exacerbated the potential for coastal erosion and inundation impacts on Kosrae. Top left: removal of coral rubble from the reef flat; Top right: Sand mining; Middle left: Dredge pits on the inner reef flat at Tafunsak; Middle right: Erosion at Walung caused by the cutting of a drainage channel at Leap; Bottom left: Erosion at the Sandy Beach Hotel caused by the seawall; Bottom right: Erosion and coastal change at Finkooca caused by the reclamation at the old Pheonix Resort and recent house construction.

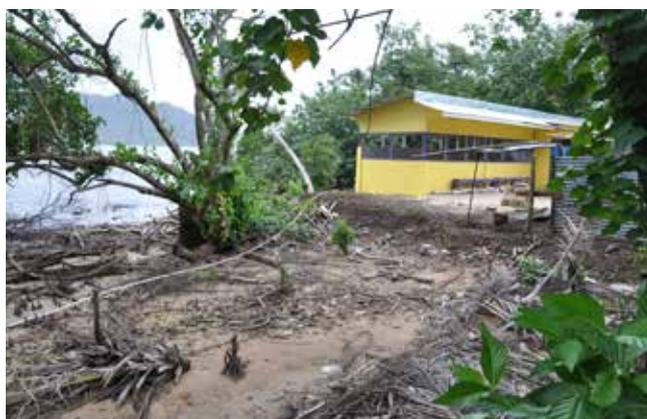
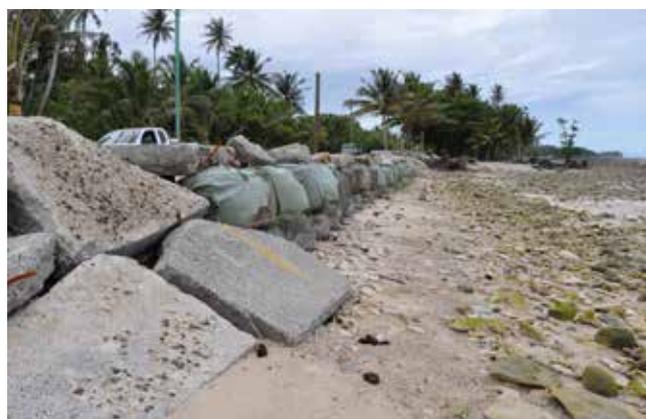
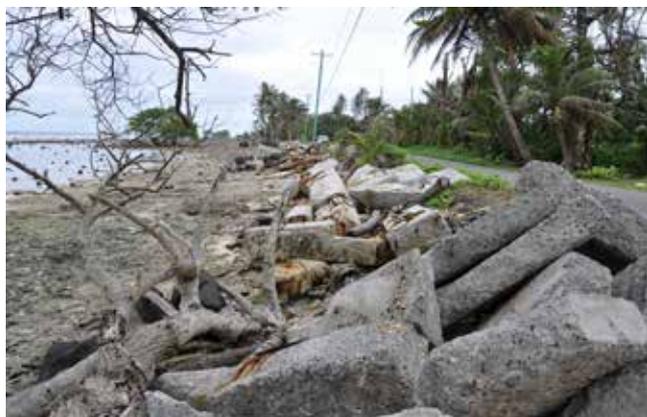
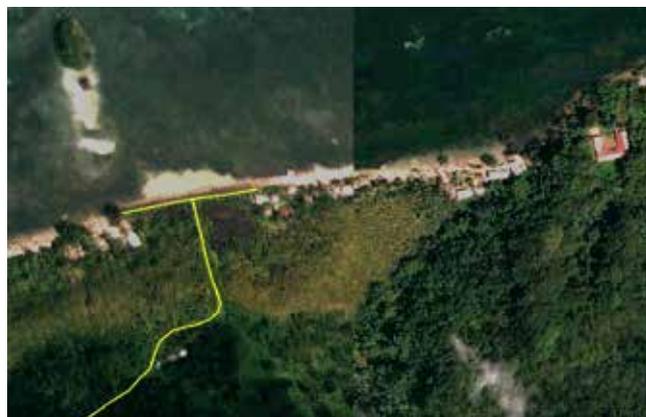
Figure 5: Recent examples of poor development activities that will lead to further coastal hazard-related problems and are not sustainable or effective in the long-term. Top left: Low-lying reclamation for a new laundromat at Tafuyat, Lelu Harbour; Top right: Concrete bag seawall to protect the road at Mosral, Malem; Bottom left: Dumped concrete rubble to attempt to protect the road at Pal, Malem; Bottom right: Access road construction through the mangrove and along the foreshore at Leap, Walung.

- The extension of the road across the wetland/mangrove area and along the shoreline at Leap in Walung (with the intention to continue the reclamation and road development to the church at Insiarf), rather than continuing it around the edge of the volcanic part of the island.

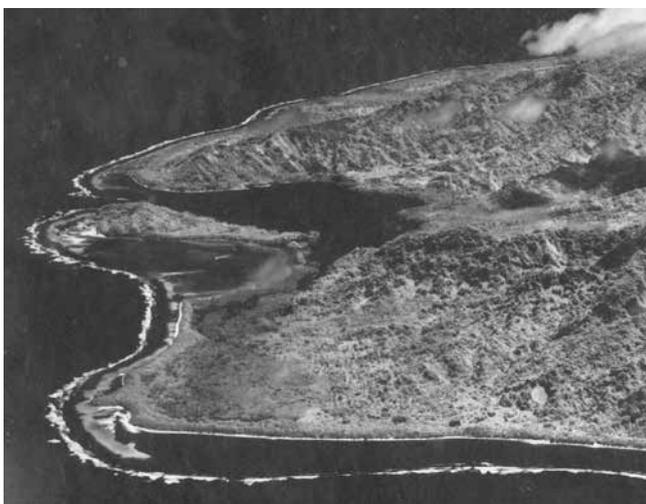
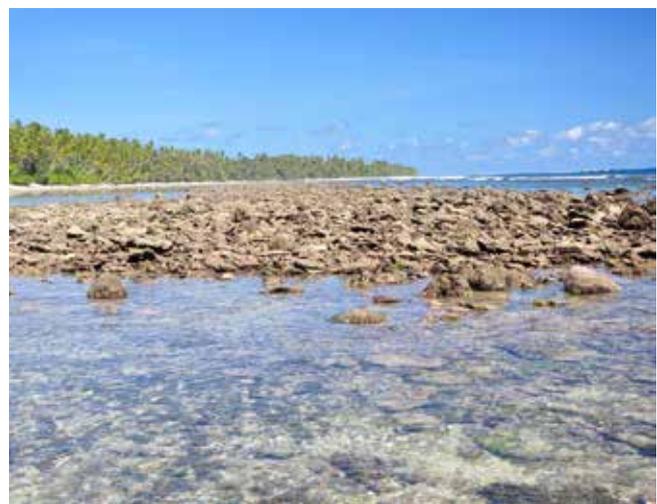
Figure 6: Aerial photograph of the north-east Kosrae coast in 1944 (left) and the remnants of the rubble ridge in 2013 at Putukte (right). The rubble ridge extending from Finaunpes all the way down the Pukushruk shoreline to Putukte can be clearly seen in 1944. The size of the ridge between Finaunpes and Finfokoa resulted in a build out of the shoreline in a bulge in the lee of the ridge. With the breakdown/removal of the rubble ridge, the sediment in this bulge in the shoreline has been redistributed along the adjacent coastline.

- **Lelu: Finfokoa and Pukushruk** – Large changes have occurred in the shoreline position at Finfokoa over the last half century and continued changes in shoreline position must be expected. However, it is expected the rate of change may be less in comparison with past change. Continued retreat of the coastline along the central section at Pukushruk will likely increase the exposure of the road to damage over time. Similarly the proximity of the road to the shoreline at Putukte suggests it will be susceptible to damage during large waves and high tides.

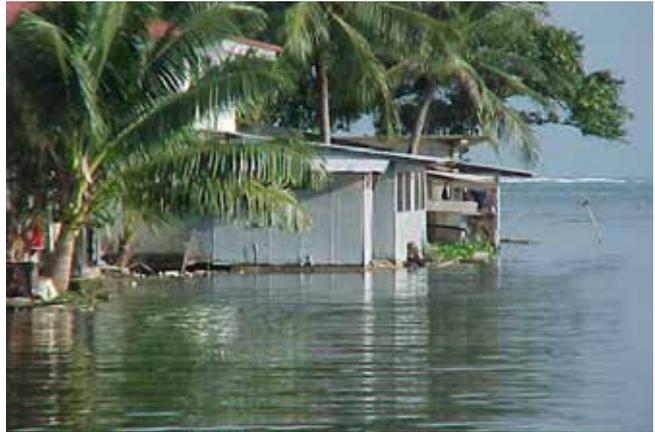
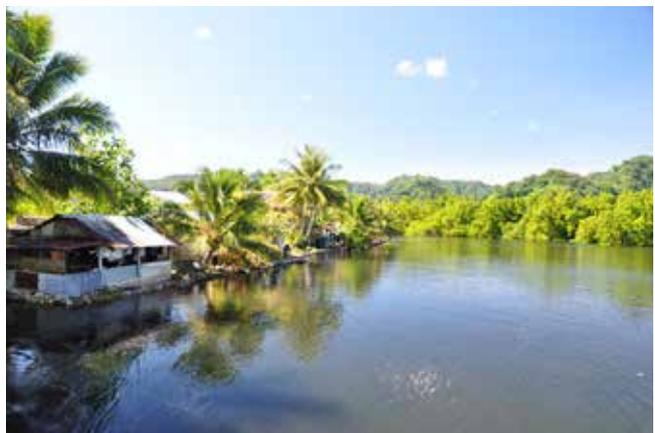
Figure 9: Low-lying reclaimed areas on Lelu Island (top) and Utwe village (bottom). Both Lelu and Utwe villages have been built on reclaimed land that is close to present day high spring tide levels. The frequency and severity of high-tide flooding will be an ever-increasing issue as sea-level rise continues. Constructing further seawalls will not prevent more frequently and severe inundation occurring in the future.

will result in increasingly more frequent damage to much of the infrastructure and property located along all parts of the coastal storm/beach berm and reclaimed areas (Figure 3). It will be increasingly difficult to maintain infrastructure and residential property located in these areas without substantial and continuous investment (for example raising reclaimed land levels in Lelu and Utwe villages).

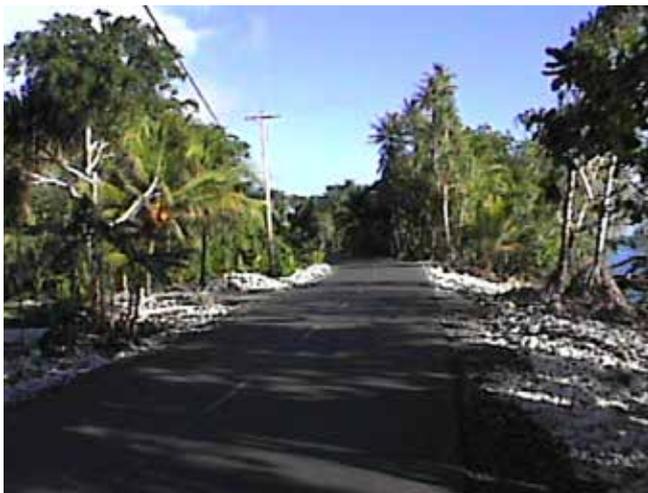
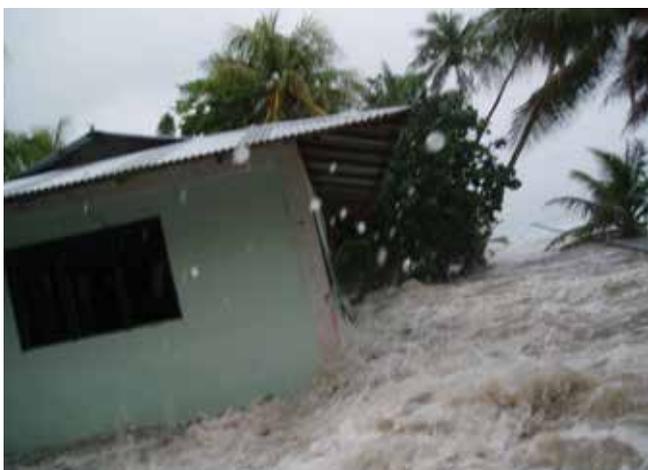
Figure 8: Overwashing of the road in South Malem during Tropical Storm 31W in December 2001 (top) and at Tafunsak during the December 2008 large swell event (bottom).

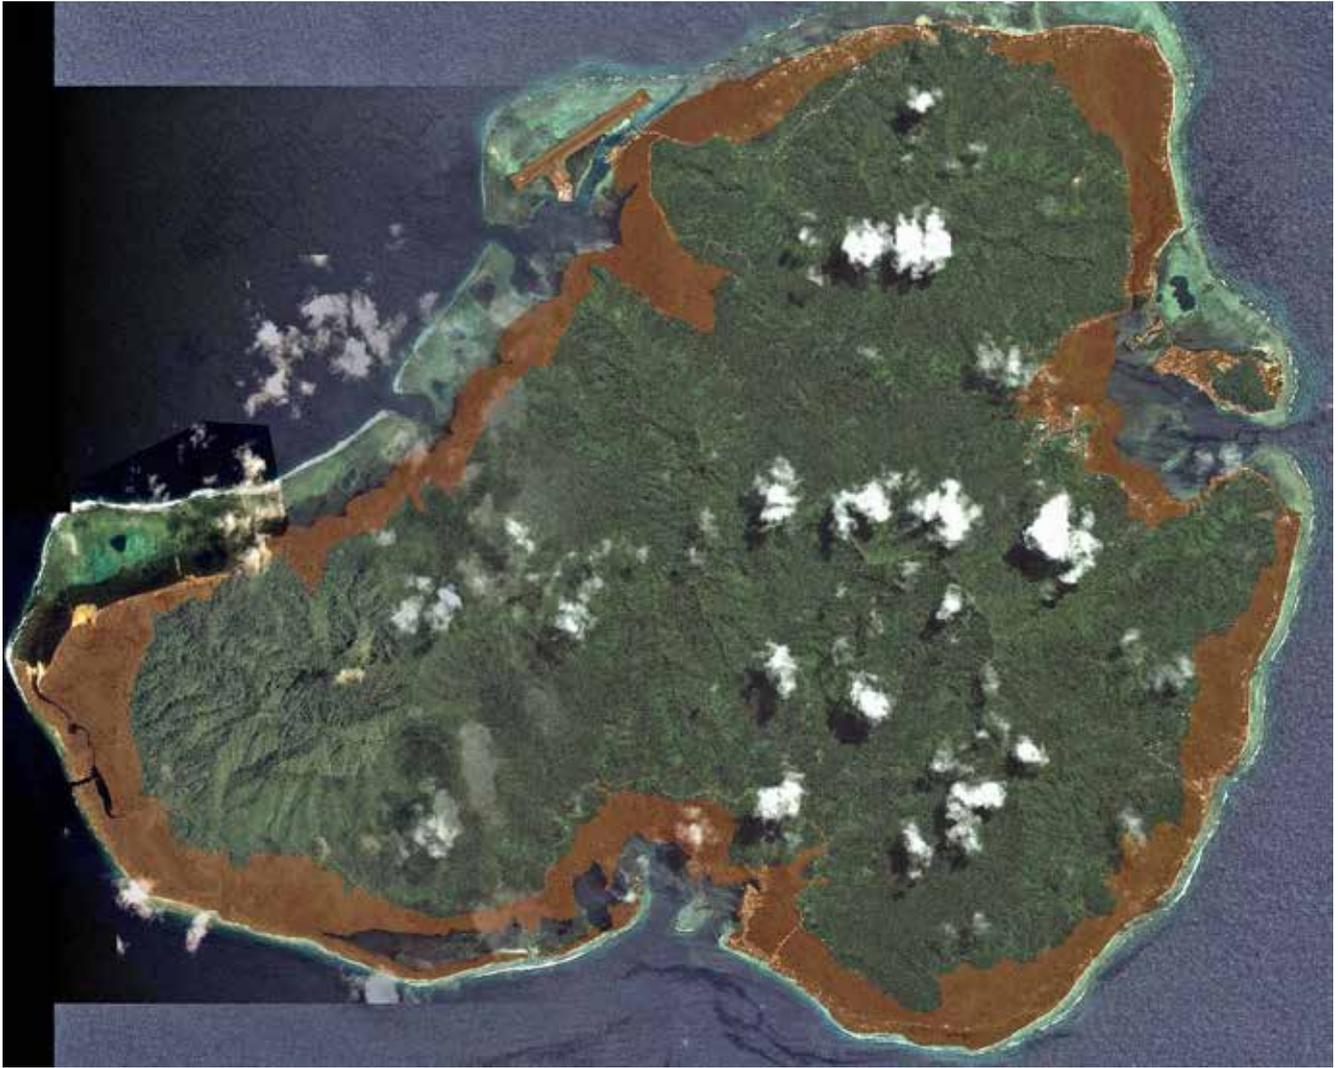
Figure 12: Low-lying coastal areas where restrictions on further development are required. The areas shown in red are largely below the 4 m MSL contour which is approximately 2 m above present day high spring tide level.

The area covered by the above development restrictions is shown in Figure 12.

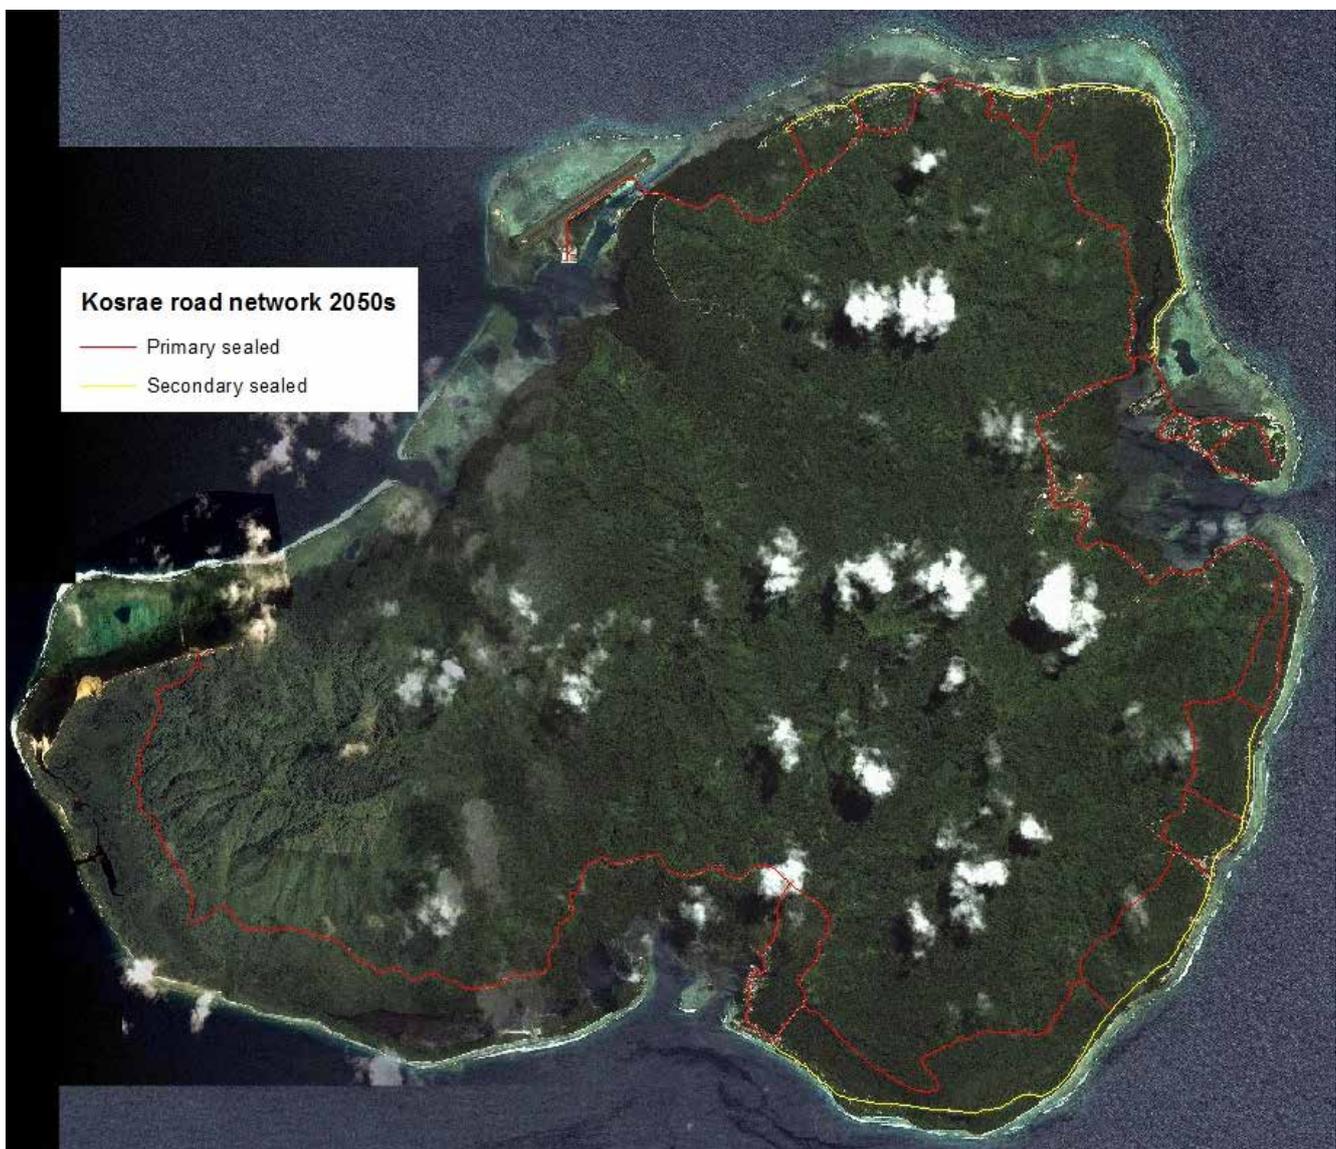
Figure 13: Potential primary and secondary sealed road network on Kosrae by the 2050s. Note: Parts of the secondary road network (current coastal road) may become impassable due to ongoing shoreline change and breaching.

By the 2050s (2 generations time) Kosrae needs to have made significant progress in implementing an adaptation strategy that repositions the majority of existing critical infrastructure and property away from the beach/storm berm areas, reclaimed areas of mangrove and low-lying wetland swamp to slightly higher ground around the base of the volcanic part of the island (Figure 13).

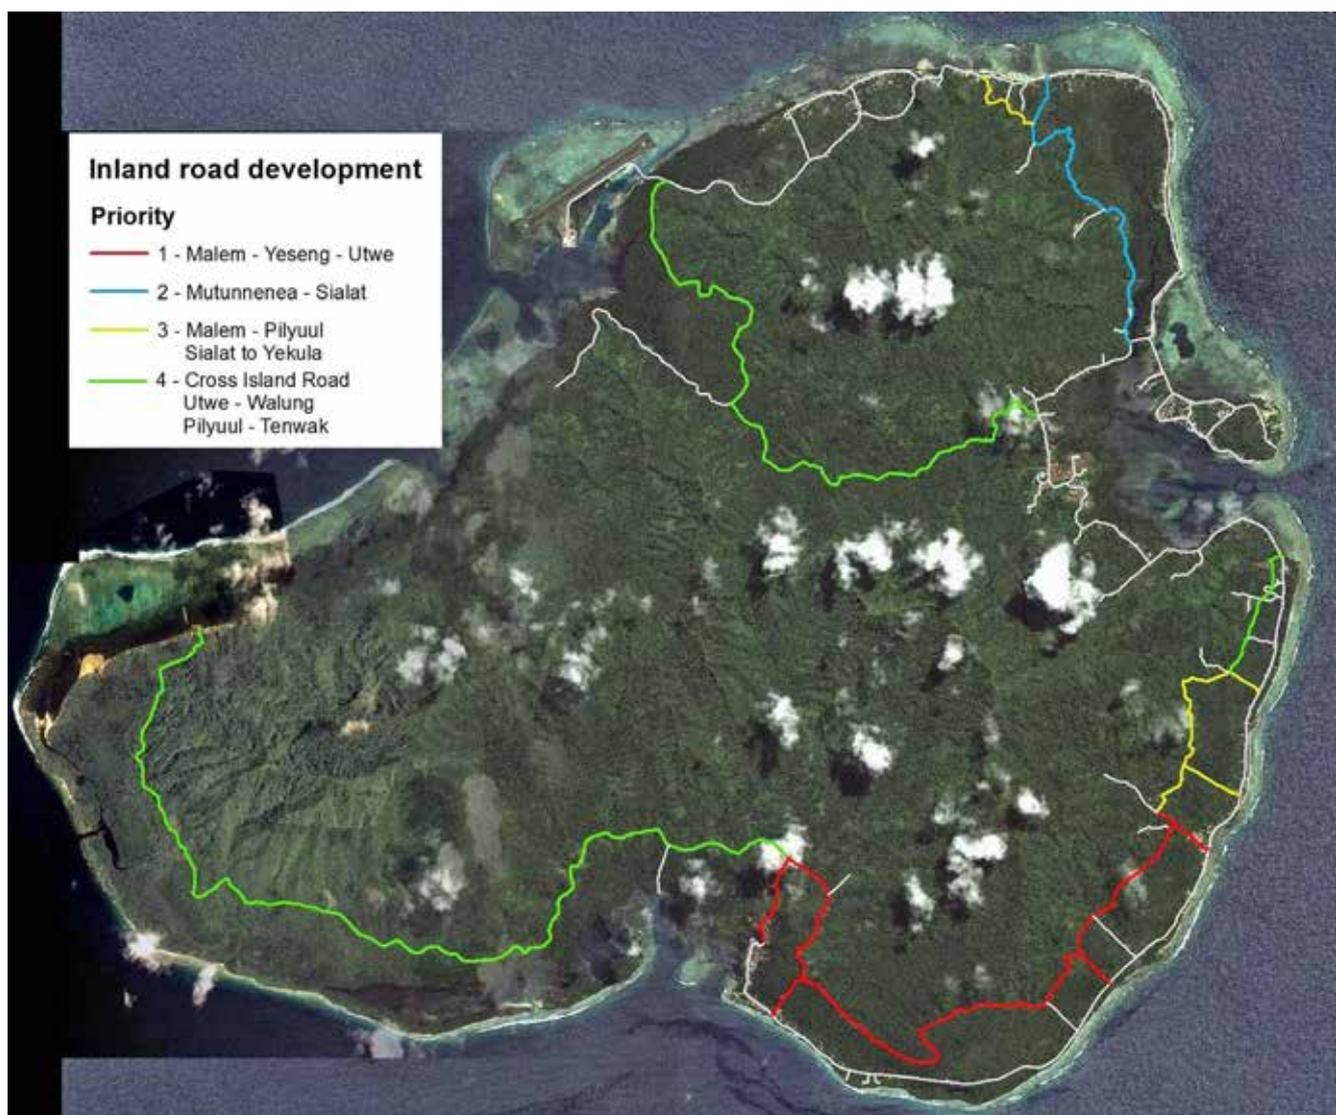
Figure 14: Priority section of the development of the inland road on Kosrae.

The prioritized redevelopment of the coastal road is summarized in Figure 14 and outlined below:

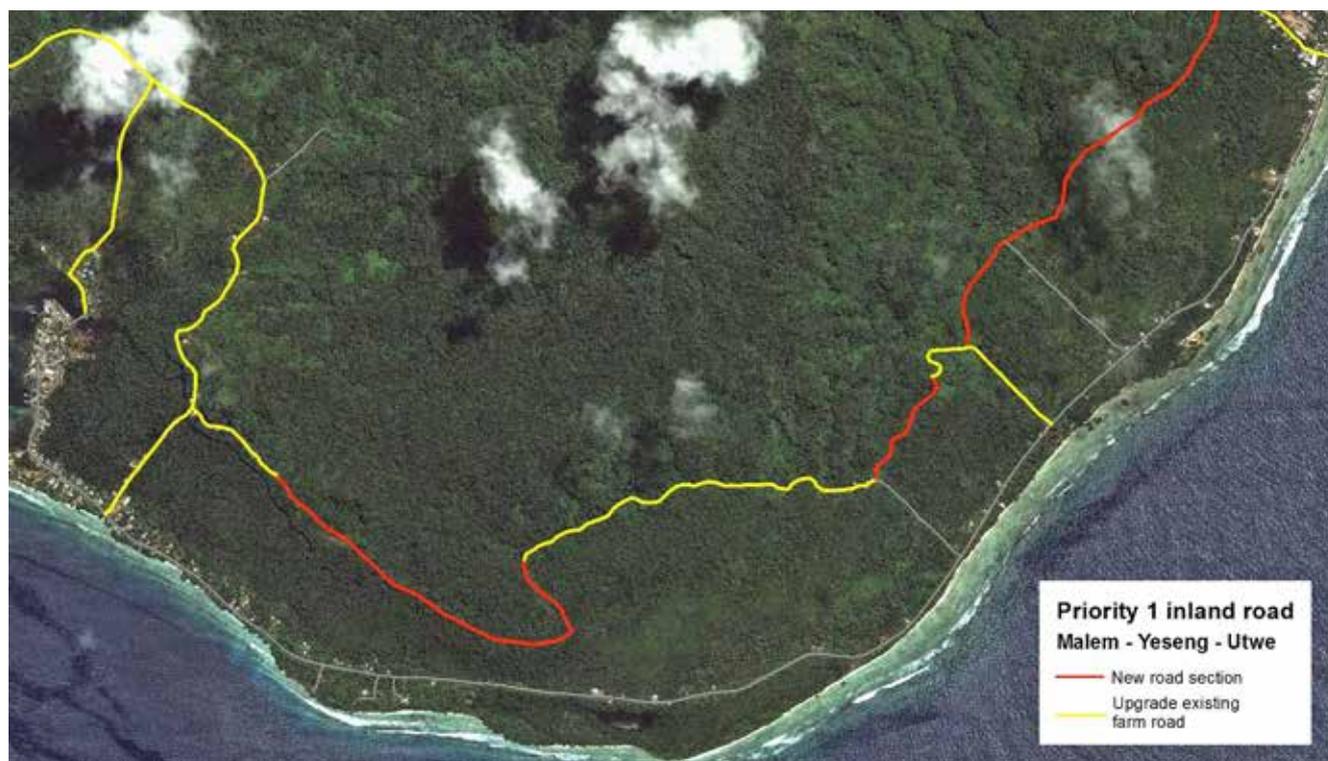
Figure 15: Indicative inland road between Utwe and Malem showing the requirements of new and upgraded sections of road.

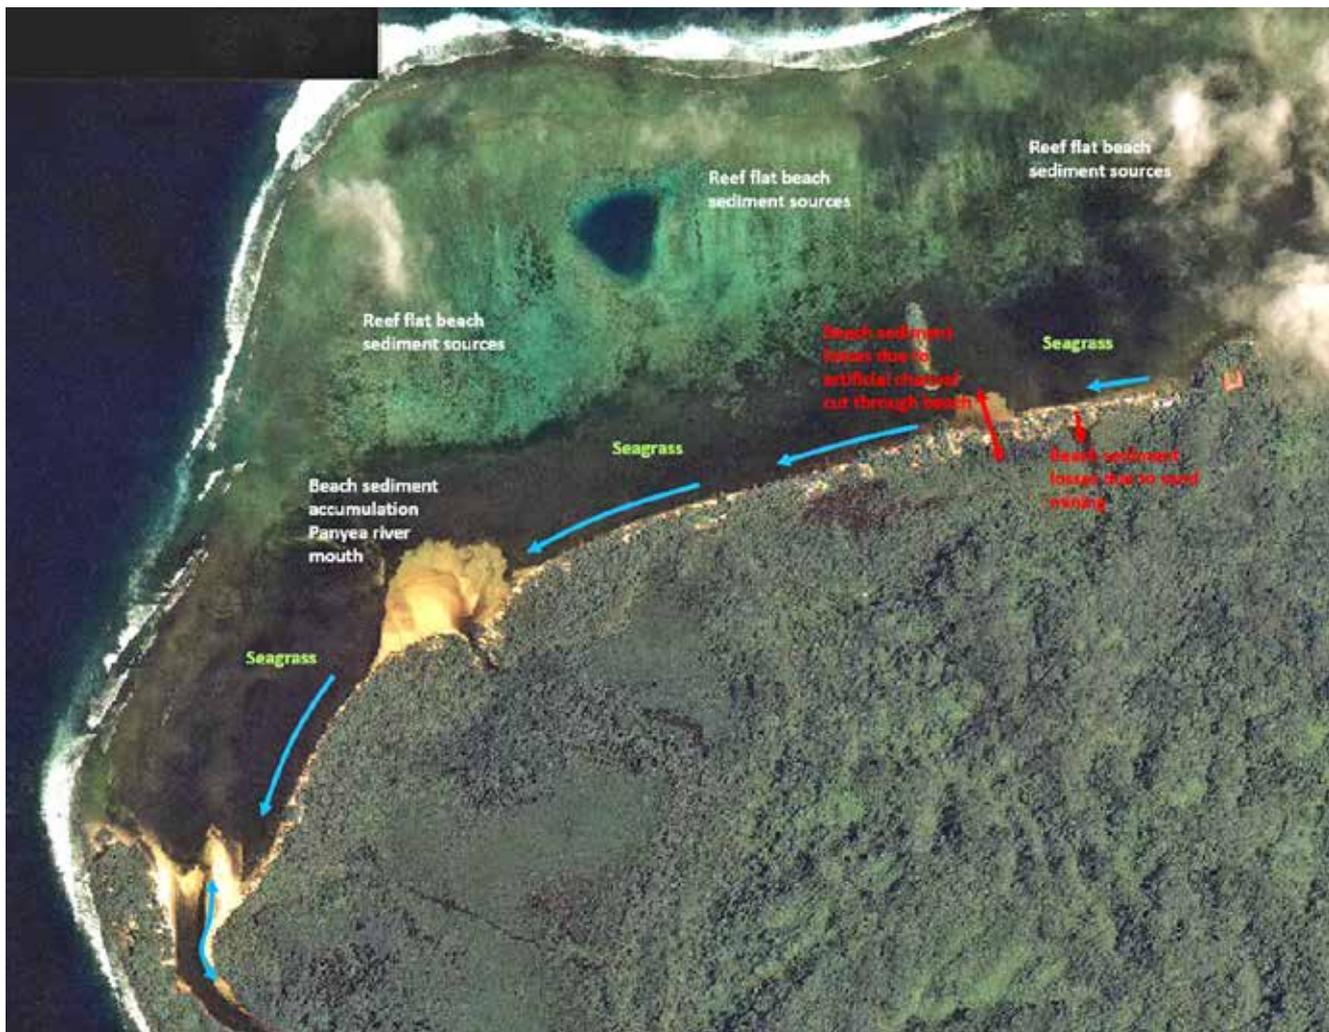
Figure B 4: Key sediment sources, longshore transport processes, and sediment losses along the Walung shoreline.

- The dredge pits at Tafunsak have been, and may well continue to be a sink of both beach and reef flat sediments.
- The net westerly longshore transport of beach sediment means that downdrift erosion problems (such as occurred at Sandy Beach and to a lesser extent at the western end of the Tafunsak seawall) are likely where poorly considered seawalls or reclamation is conducted.

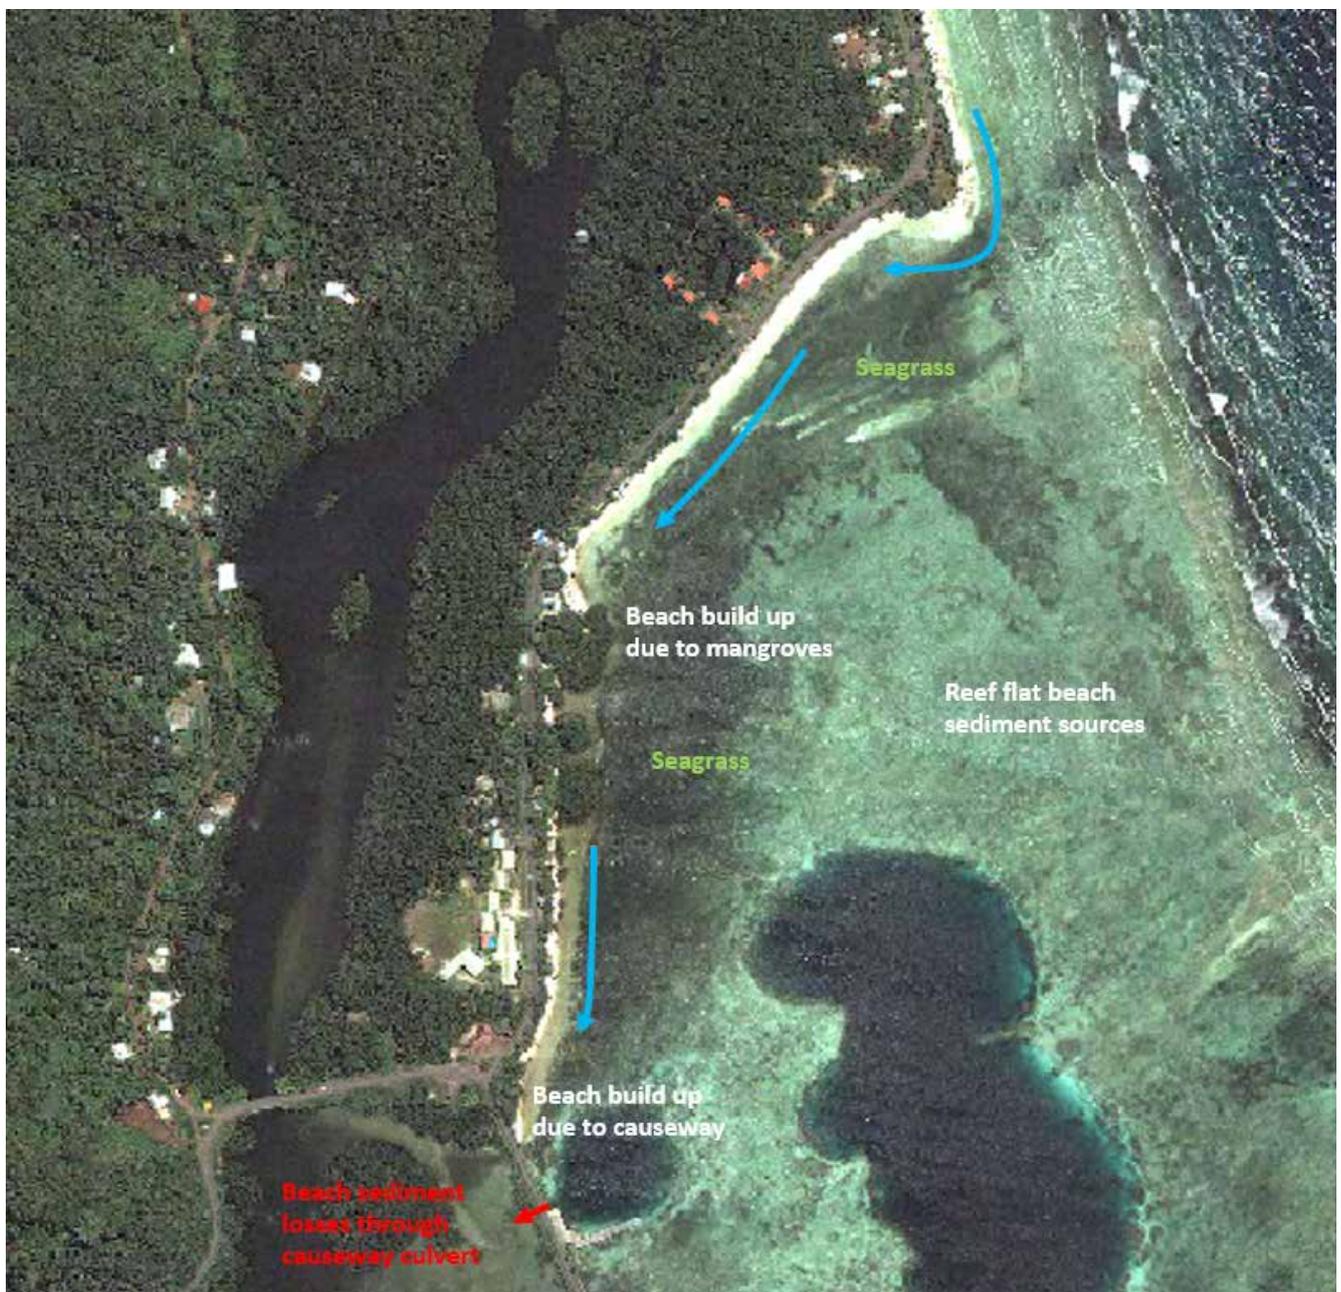
Figure B 5: Key sediment sources, longshore transport processes, and sediment losses along the Putukte to Finpukal shoreline.

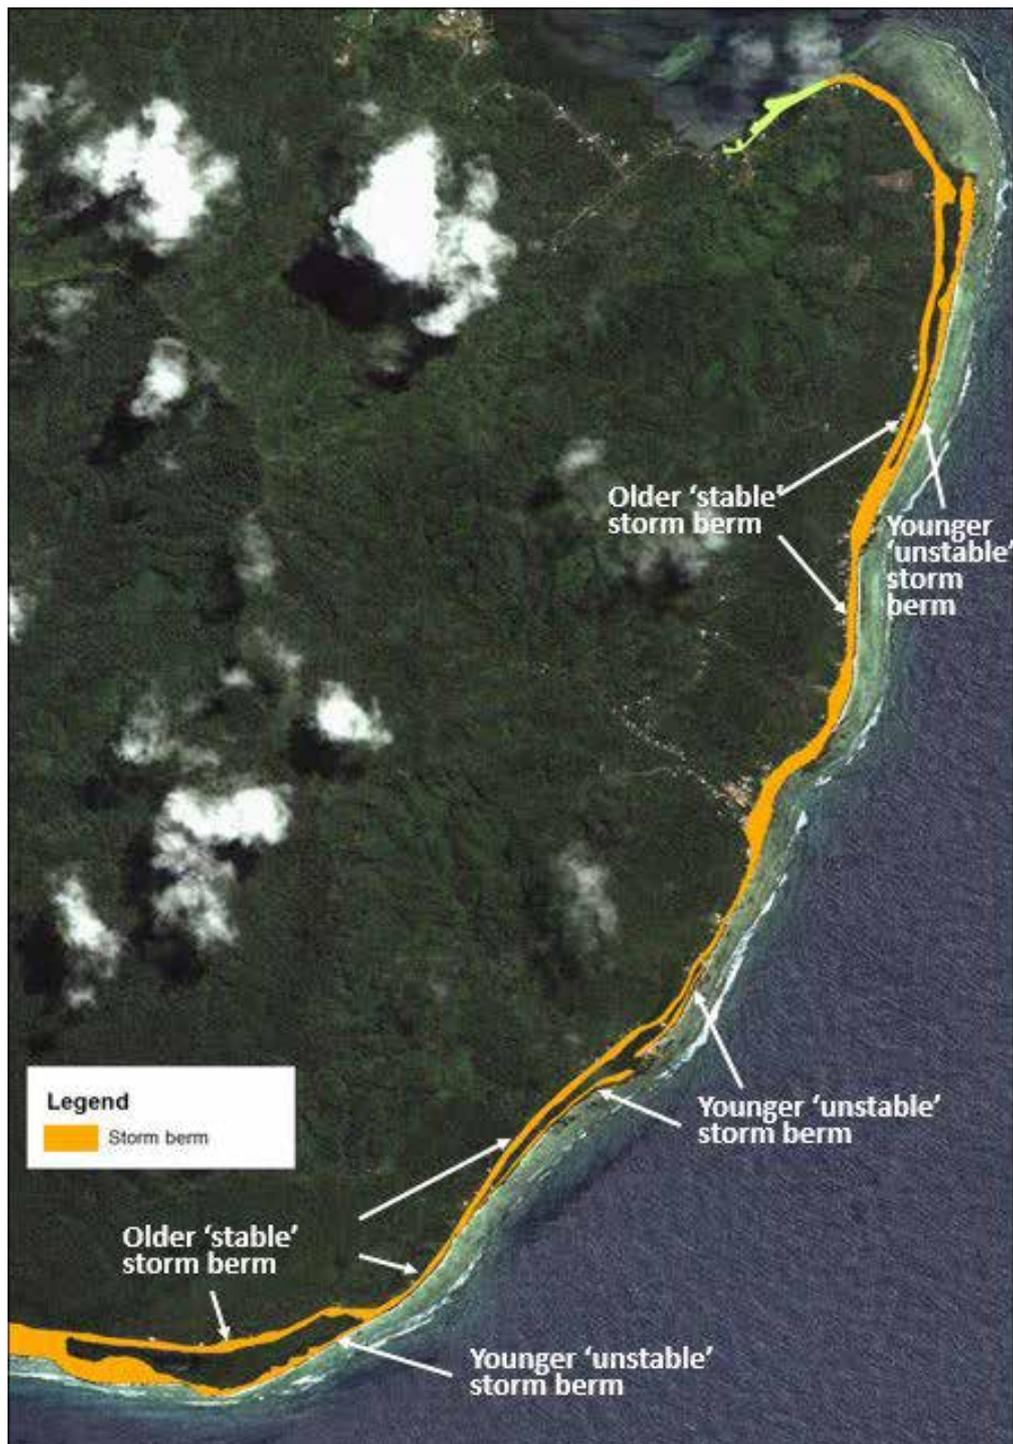
Figure B 7: Location of the storm berm along the Malem coast.

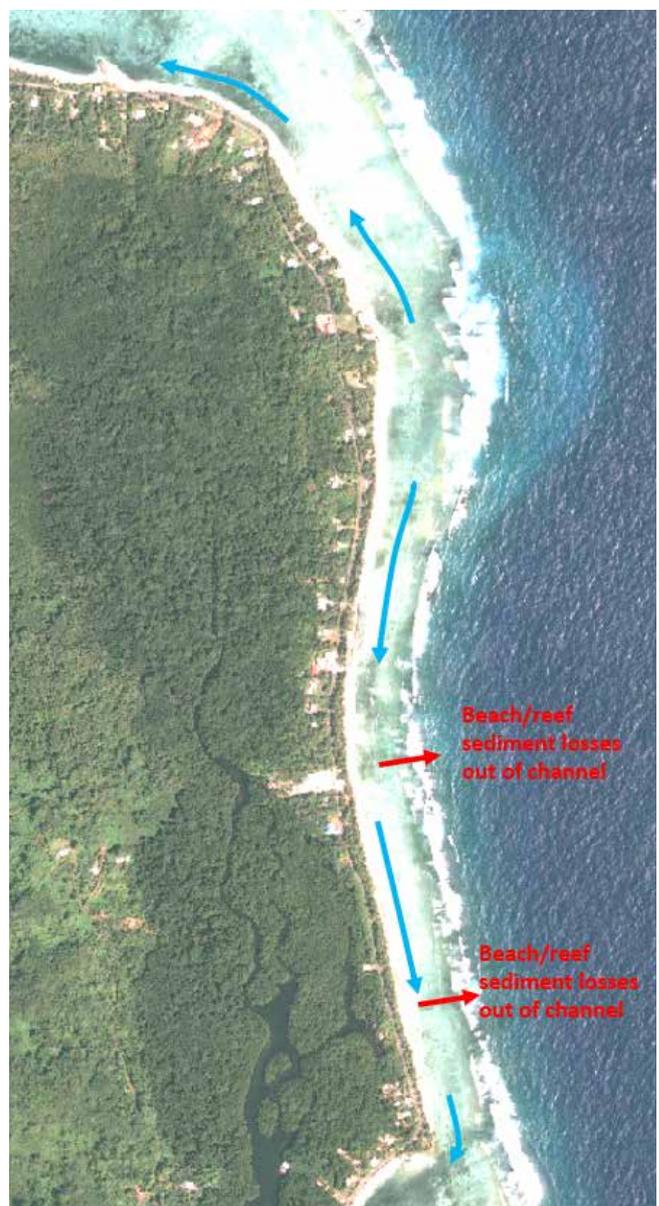
Figure B 10: Key sediment sources, longshore transport processes, and sediment losses along the Pukusruk shoreline.

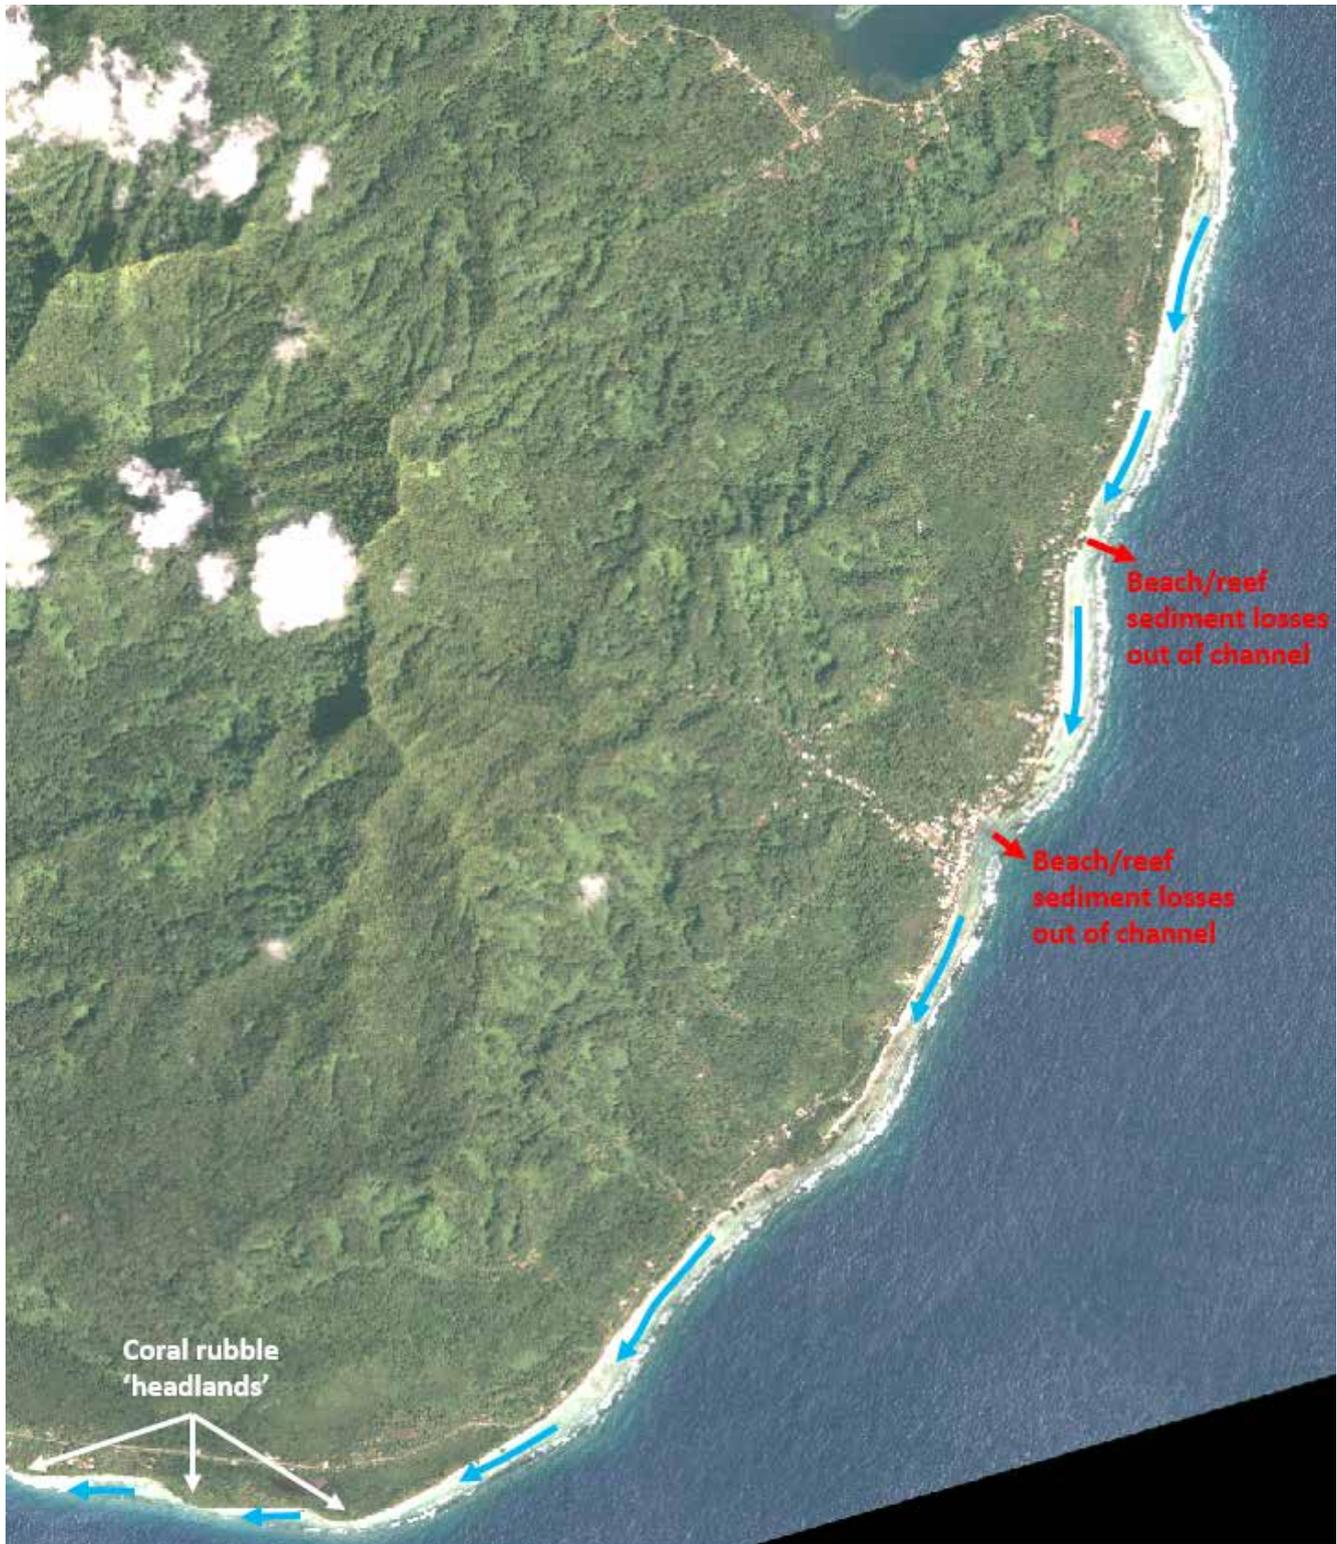
Figure B 11: Key sediment sources, longshore transport processes, and sediment losses along the Malem shoreline.

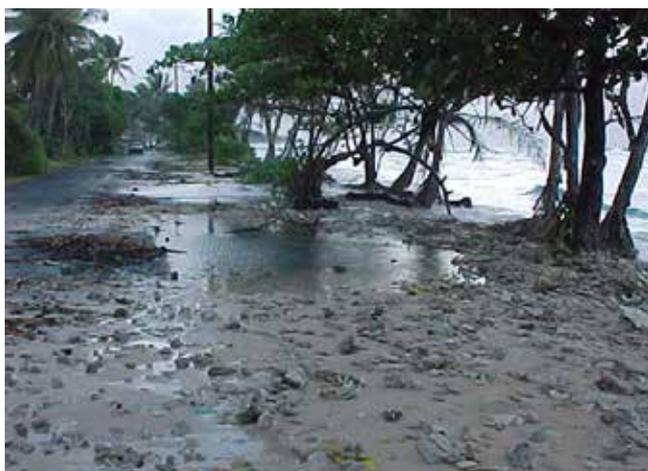
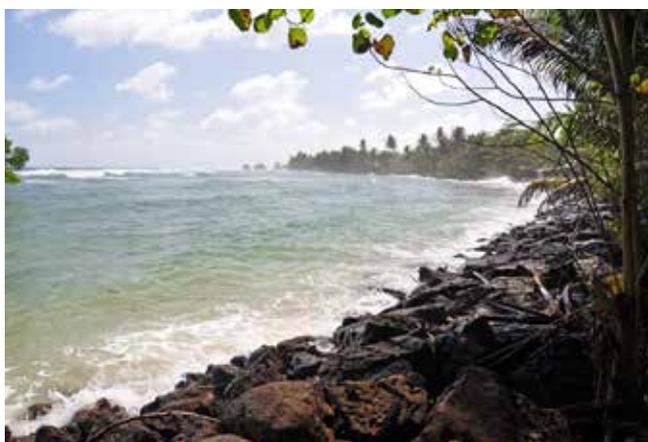
Figure C 2: Wave overwashing at Fukrin in Malem during February 2000 (left) and high tide wave overtopping of the seawall at Malem village during December 2010).

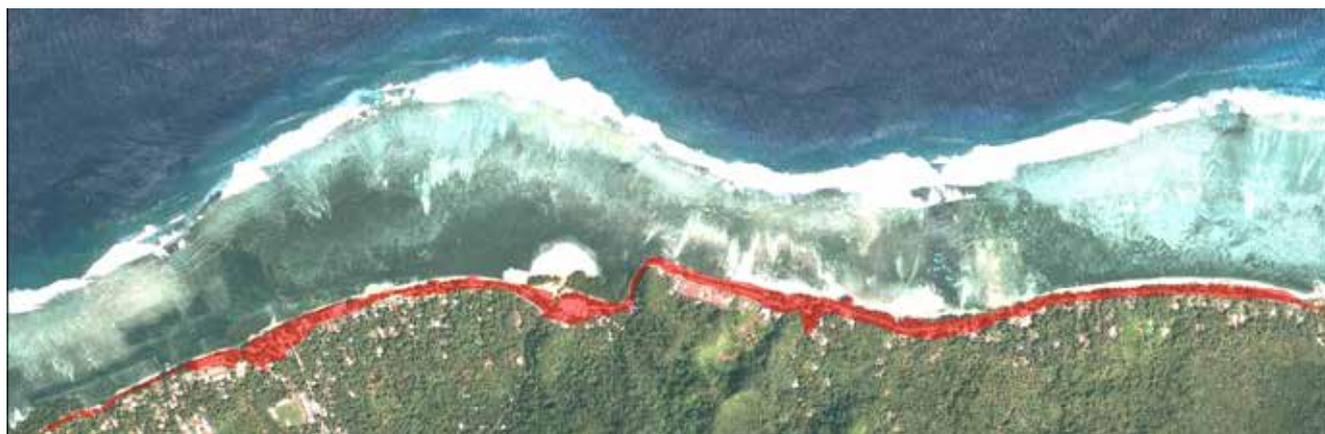
Figure C 4: Extent of inundation along the Tafunsak coastline during the swell event of 8-9 December 2008. Inundation extent information courtesy of KIRMA.
